**City and County of Swansea**

**Building at Risk Register**

**Update 1 – May 2016**

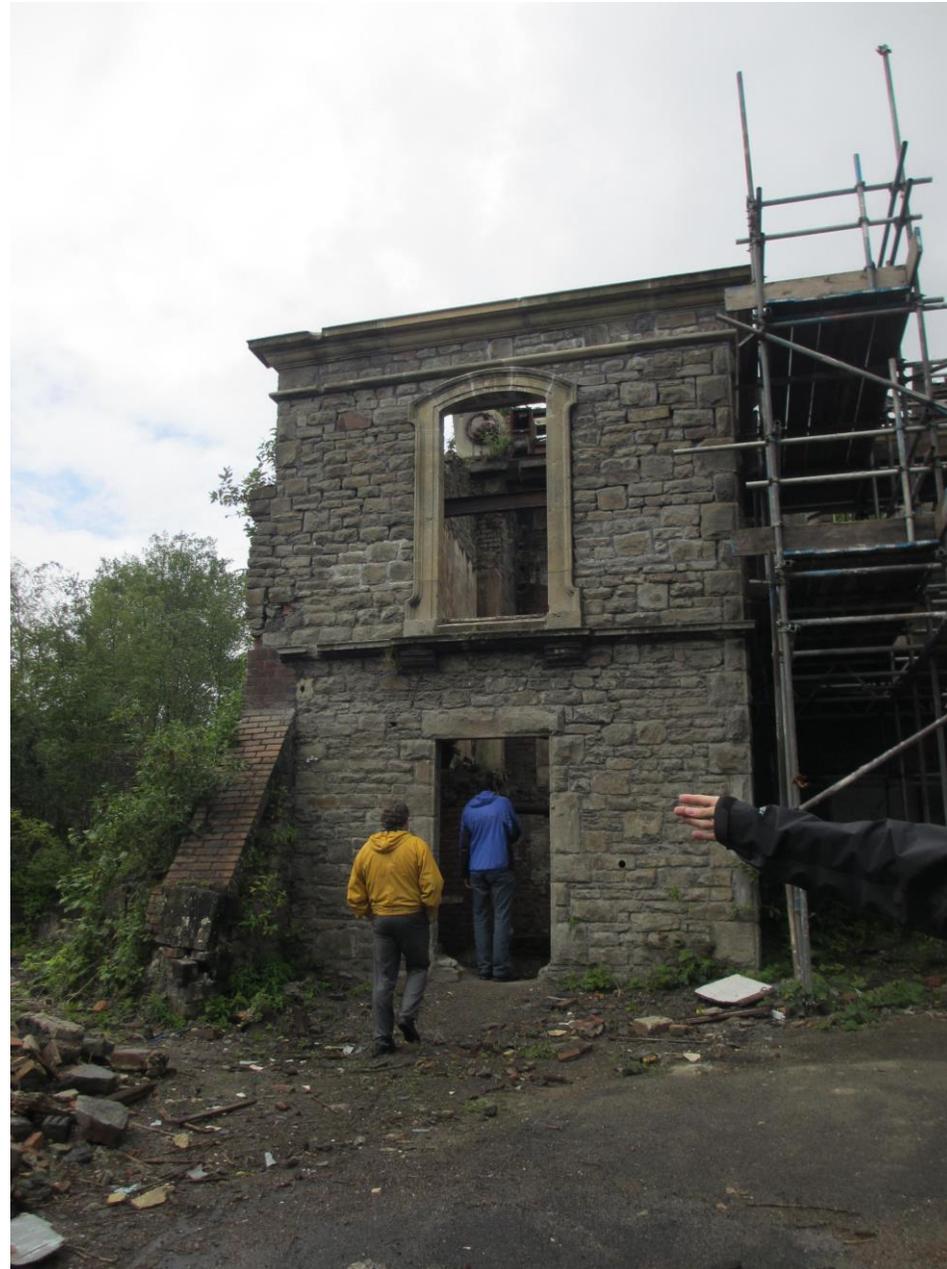
| <b>Name</b> | Laboratory building |

| <b>Current Condition and use</b> | Urgent works were undertaken in 2013 to remove collapsed roof structure, underpin walls and rebuild masonry/ wall tops |
| <b>Risk Grade</b> | 1 – Extreme Risk |

| <b>Current situation/ action needed</b> | Still at extreme risk but risk of imminent collapse averted and main walls now structurally sound. |

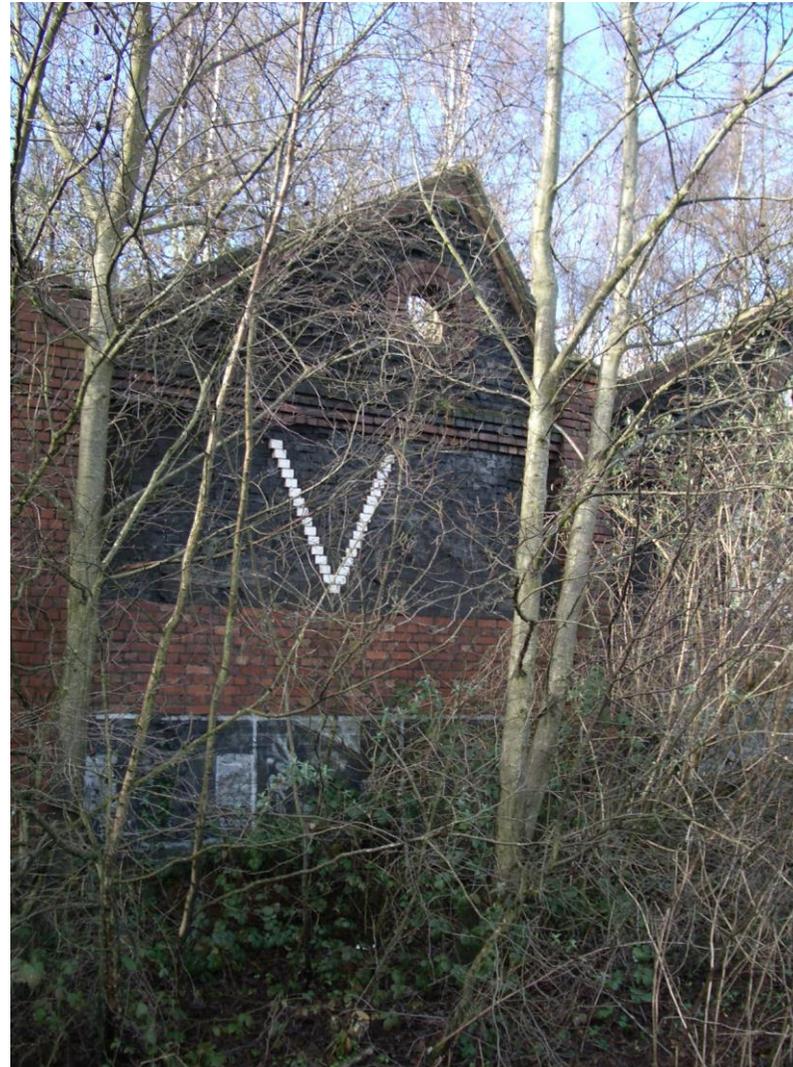
| <b>Name</b> | Vivian Locomotive shed |

| <b>Current Condition and use</b> | The remaining structure was propped with scaffold framework in ..... |
| <b>Risk Grade</b> | 1 – Extreme Risk |

| <b>Current situation/ action needed</b> | Scaffold is a holding position. Building is still deteriorating. |

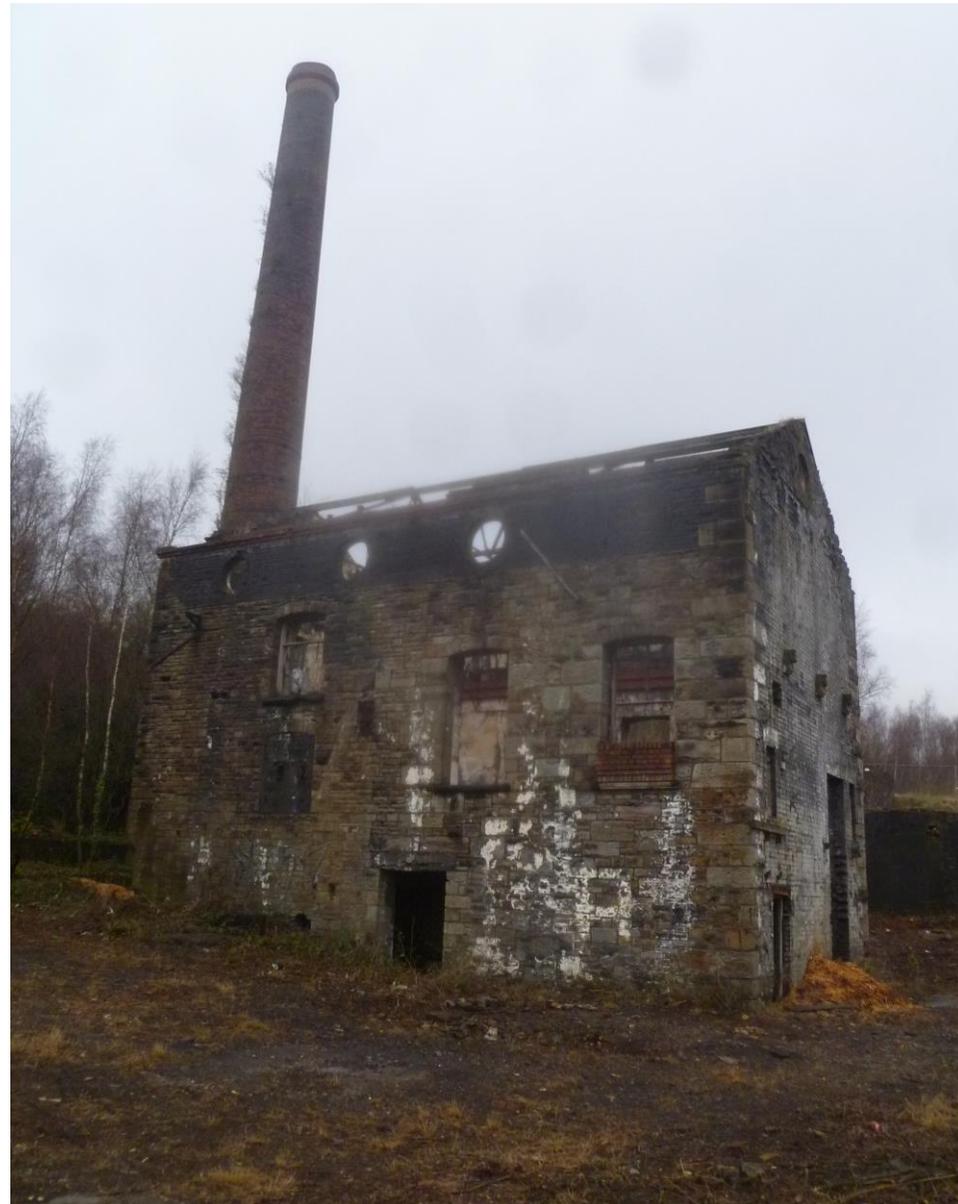
| <b>Name</b> | Vivian Engine House |

| <b>Current Condition and use</b> | Roofless and devoid of internal features |
| <b>Risk Grade</b> | 1 – Extreme Risk |

| <b>Current situation/ action needed</b> | Scope of repairs and potential uses to be drawn up.<br>No work since 2013 BAR report |

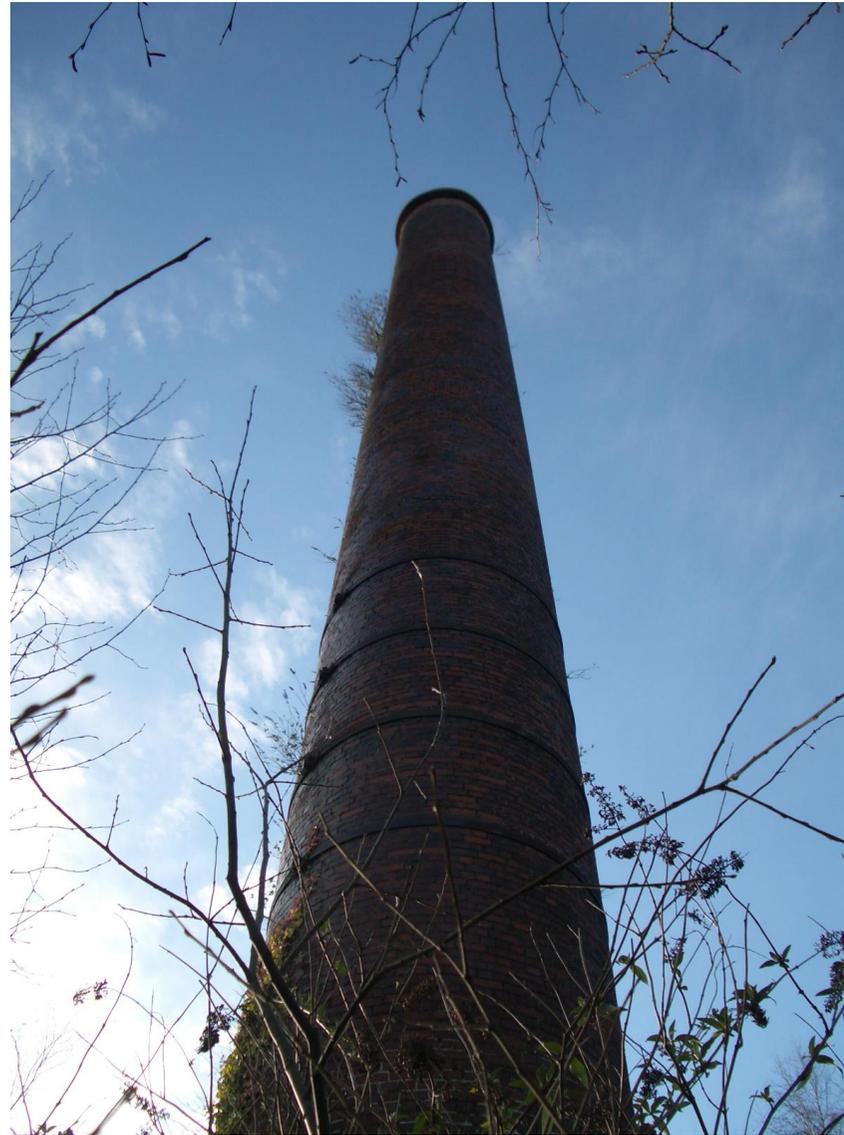
| <b>Name</b> | Vivian Engine House Chimney |

| <b>Current Condition and use</b> | In need of repointing |
| <b>Risk Grade</b> | 3 – At Risk |

| <b>Current situation/ action needed</b> | Inspected by steeple jack and vegetation removed. This has confirmed that the chimney is structurally sound but that repointing is required. Level of risk reduced from 2013 assessment. |

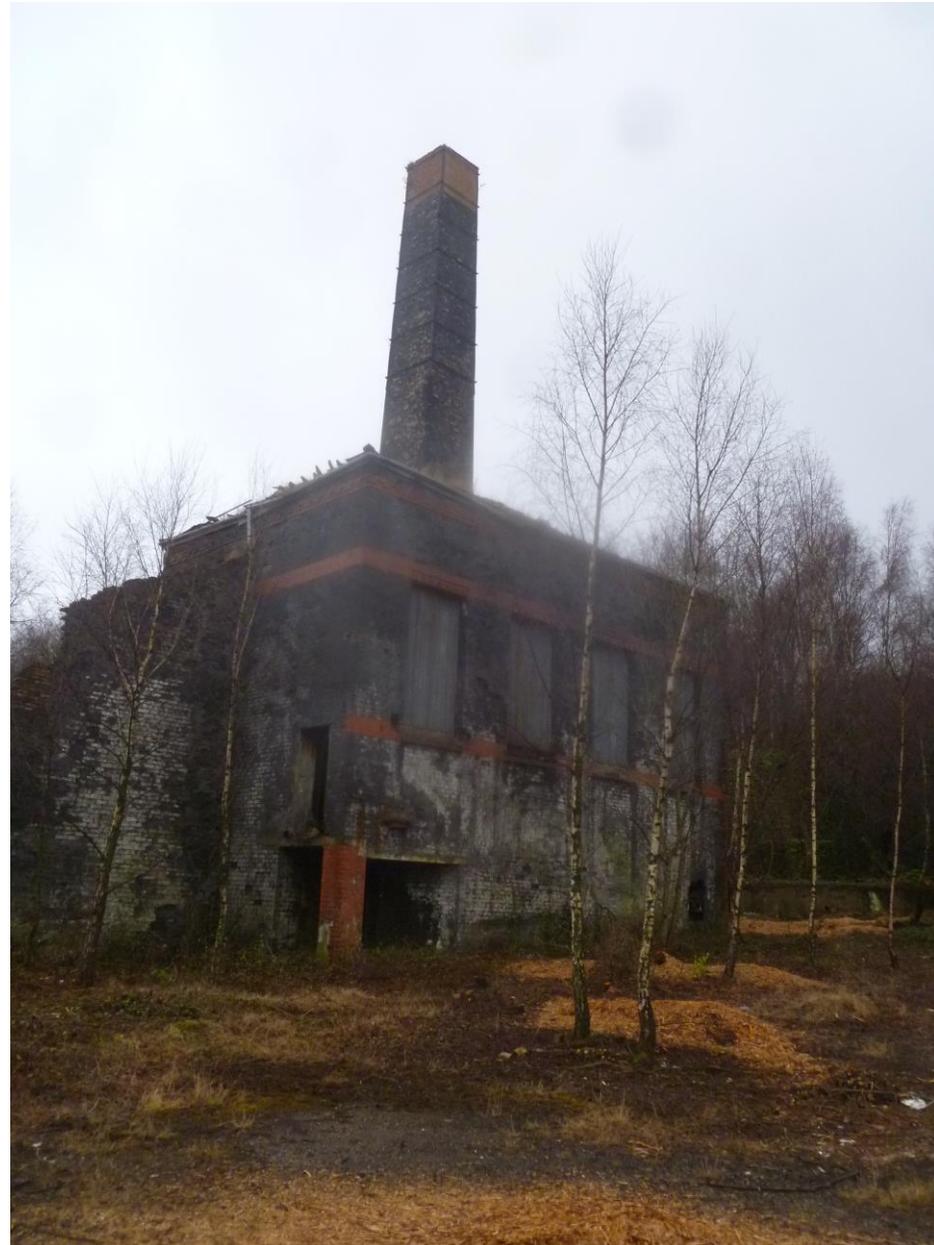
| <b>Name</b> | Musgrave Engine House & adjacent Chimney Stack |

| <b>Current Condition and use</b> | Copper slag bricks are spalling. Roof less.<br>Musgrave engine in situ<br>Also a Scheduled Ancient Monument |
| <b>Risk Grade</b> | 1 – Extreme Risk |

| <b>Current situation/ action needed</b> | Scope of repairs has been drawn up and sources of funding is being investigated. |

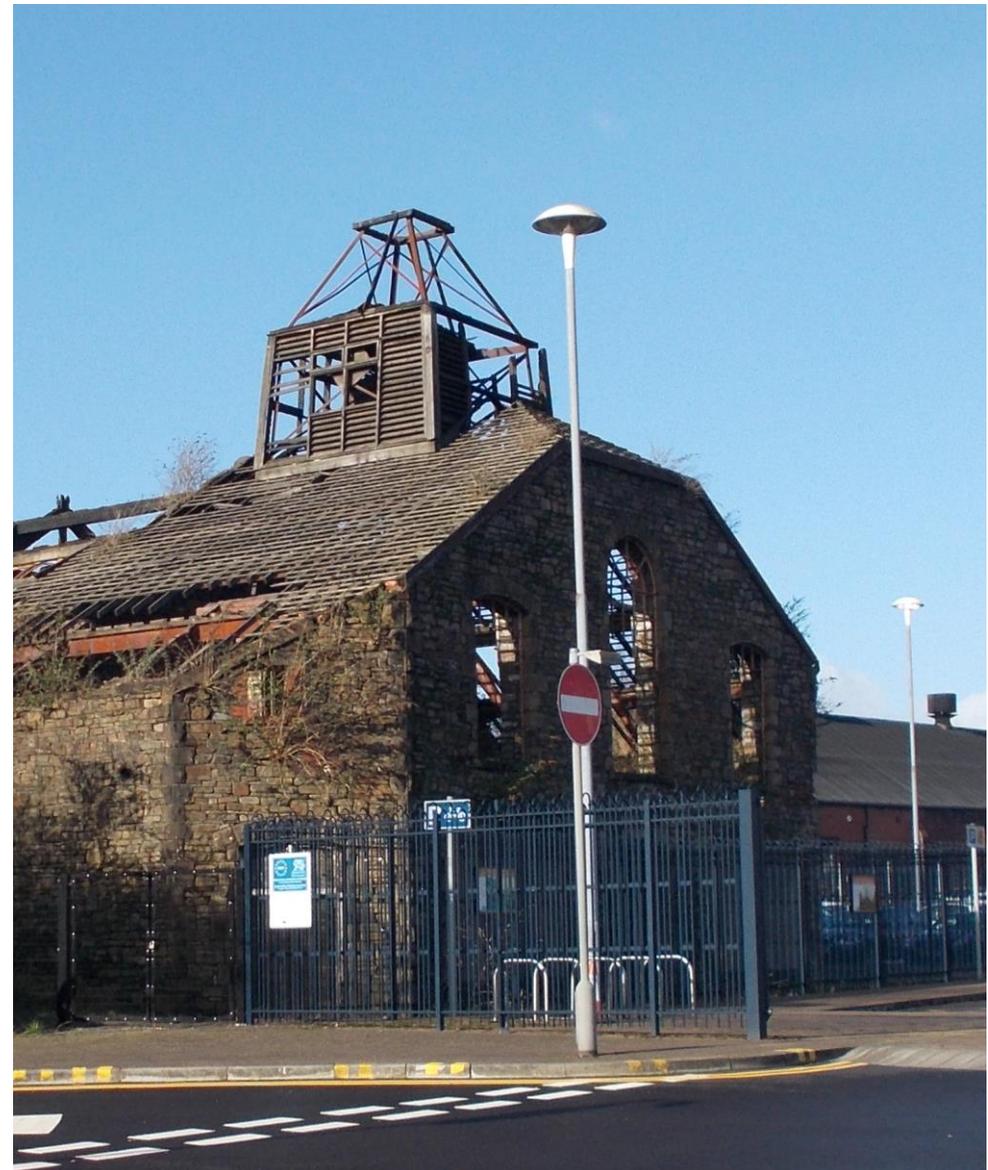
| <b>Name</b> | Canteen building<br>(Power House) |

| <b>Current Condition and use</b> | This building was reroofed in the 1980. Fire damaged at a later date and now roofless and devoid of most internal features. The walls are in reasonable condition. Metal trusses remain in situ. |

| <b>Current situation/ action needed</b> | Building proposed for HLF Heritage Enterprise project for conversion to distillery and visitor centre for copperworks |

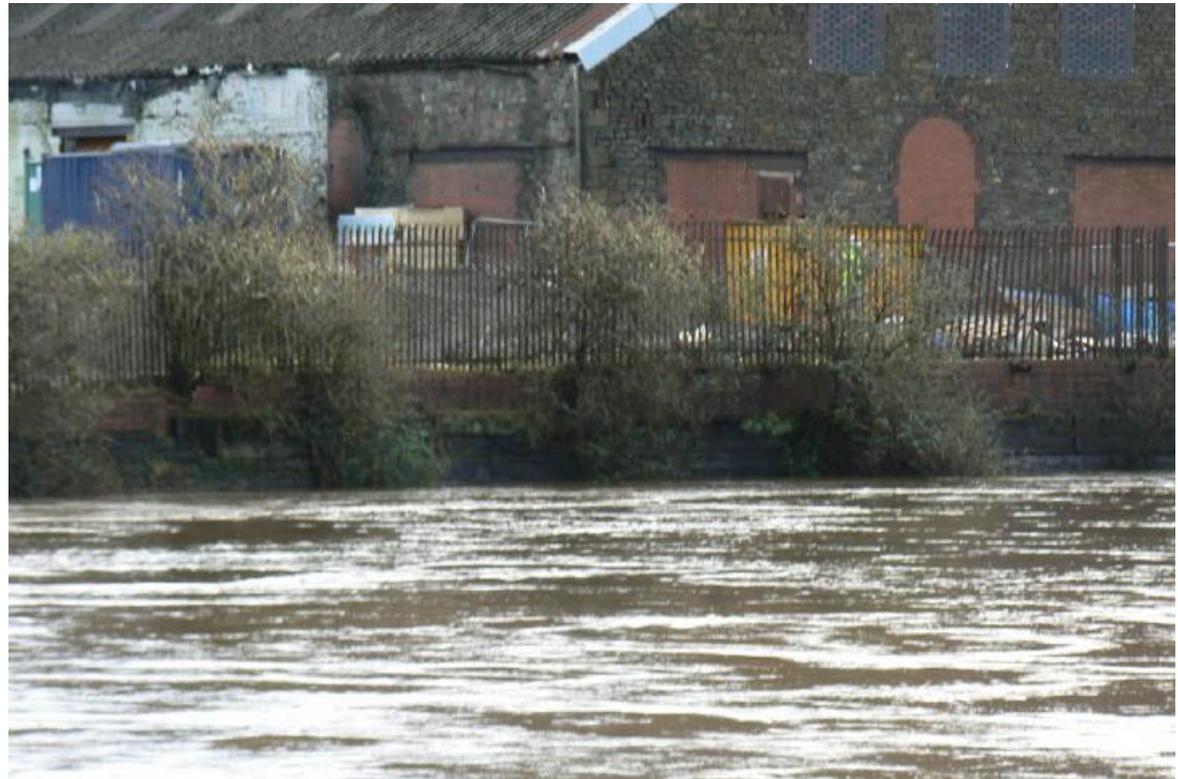
| <b>Name</b> | Quay Walls at former Upper Bank Works |

| <b>Current Condition and use</b> | Disrupted by vegetation and access difficult |

| <b>Current situation/ action needed</b> | Vegetation removal and consolidation |

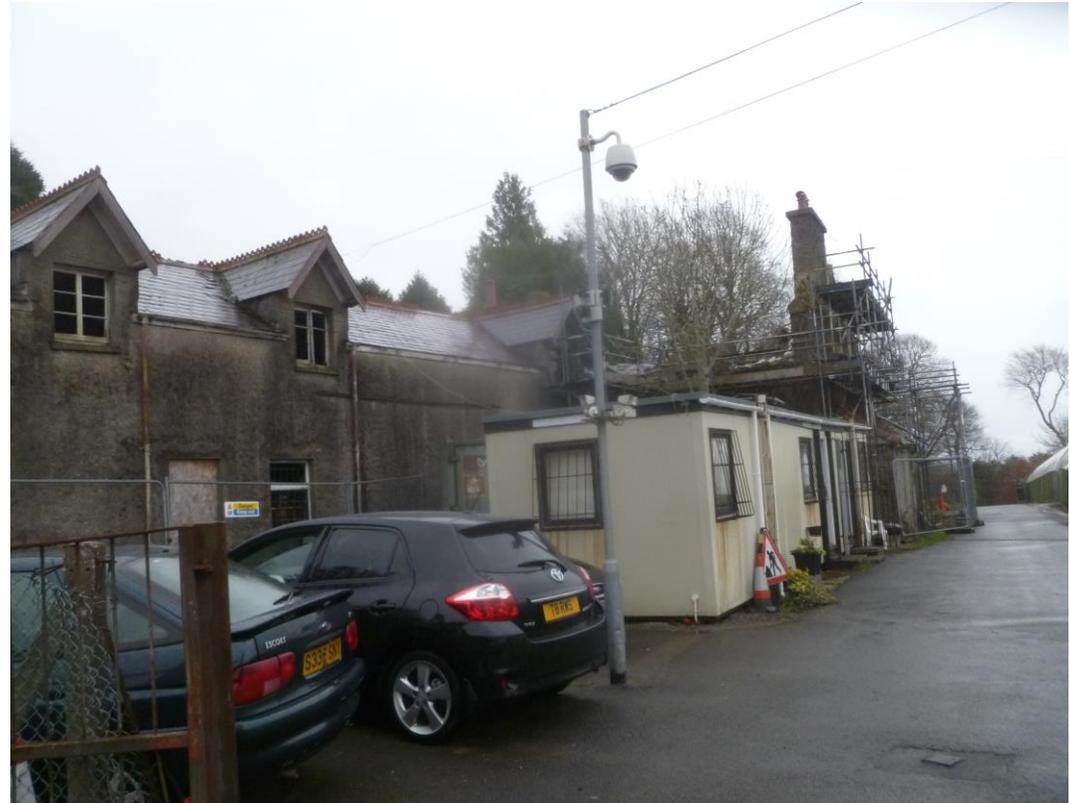
| <b>Name</b> | Veranda House |

| <b>Current<br/>Condition and<br/>use</b> | Derelict and Fire damaged.<br>Located in a Historic Park |

| <b>Current situation/<br/>action needed</b> | Building made safe in<br>summer of 2013 following<br>fire damage.<br>No work since 2013 |

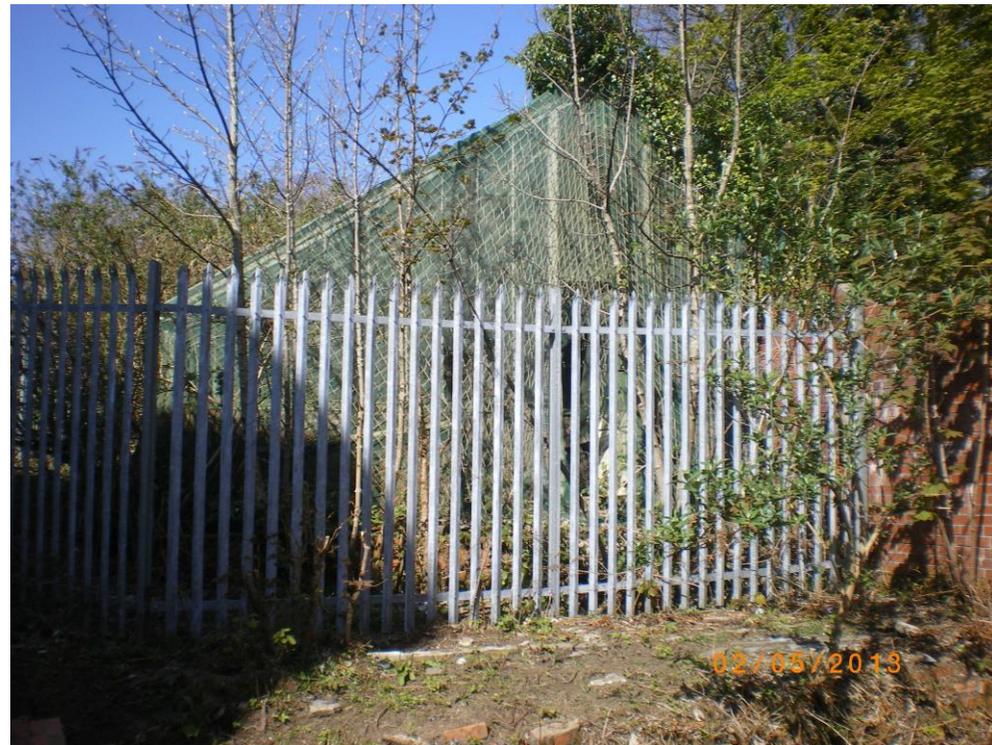
| <b>Name</b> | Clyne Gardens Glass Houses |

| <b>Current Condition and use</b> | Listed in a ruinous state<br>Located in a Historic Park |

| <b>Current situation/ action needed</b> | In a very poor condition and fenced to prevent public access.<br>No work since 2013 |

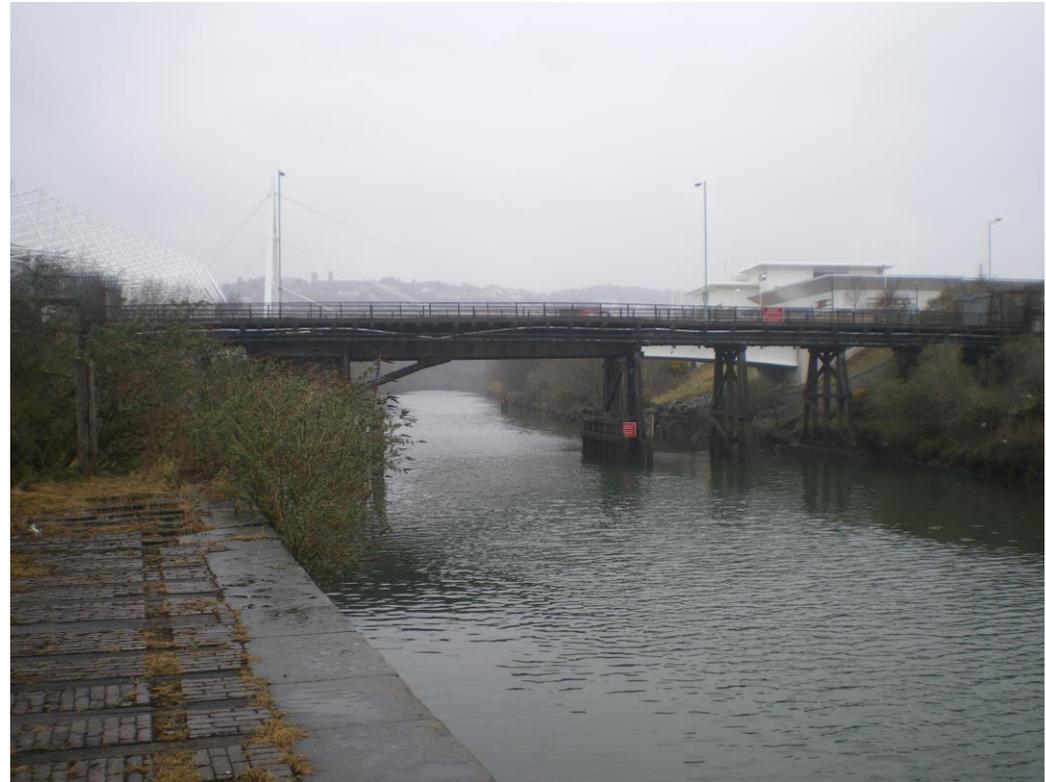
| <b>Name</b> | Morfa Bridge (also known as the Bascule Bridge) |

| <b>Current Condition and use</b> | In a poor structural condition<br>Also a Scheduled Ancient Monument |

| <b>Current situation/ action needed</b> | Condition being monitored.<br>Fenced to restrict public access and navigation not allowed below.<br><br>Detailed condition survey undertaken and repair proposals being drawn up. |

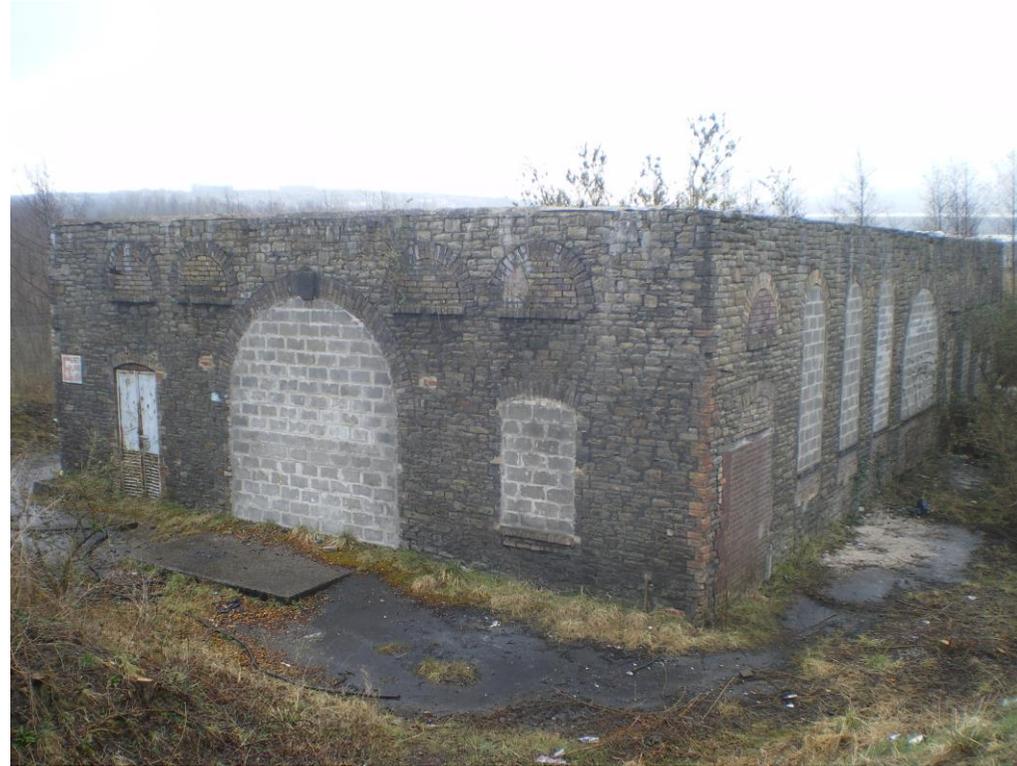
| <b>Name</b> | Former Annealing building at Beaufort tinplate works |

| <b>Current Condition and use</b> | Roof has been removed. Now a shell. Walls are in reasonable condition. No internal features remain. |

| <b>Current situation/ action needed</b> | In an isolated location – difficult to reuse as a stand alone structure. Best option may be to require reuse as part of development of wider Council owned site.<br>No work since 2013 |

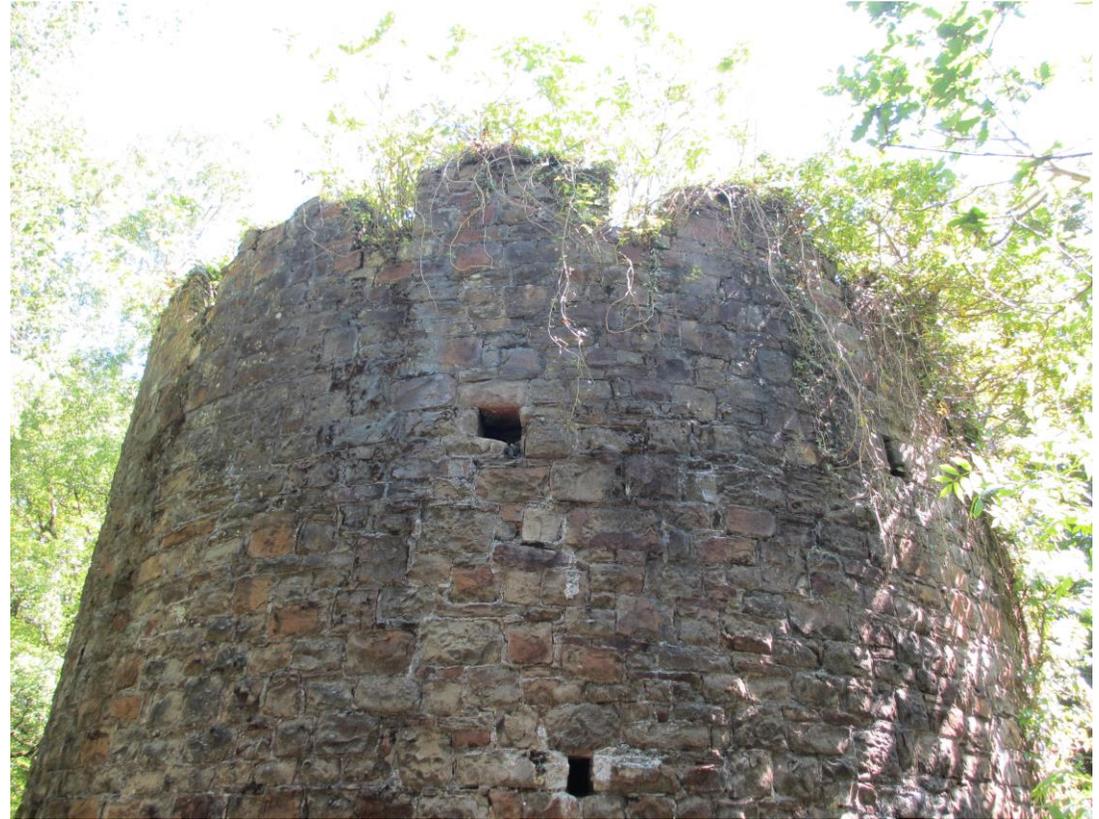
| <b>Name</b> | The Ivy Tower |

| <b>Current Condition and use</b> | In need of vegetation removal, repointing and works to internal space.<br>Also a Scheduled Ancient Monument<br>Potential for arsenic contamination<br>Fenced to reduce risk from falling masonry |

| <b>Current situation/ action needed</b> | No proposals at present<br>No work since 2013 |

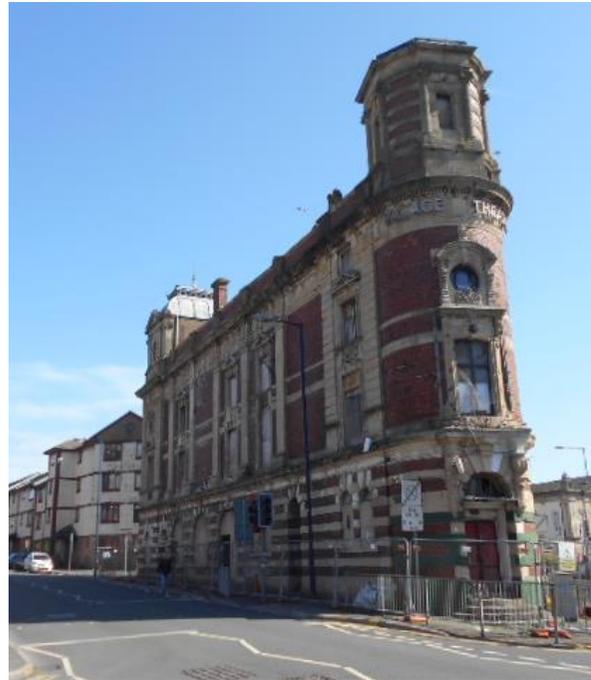
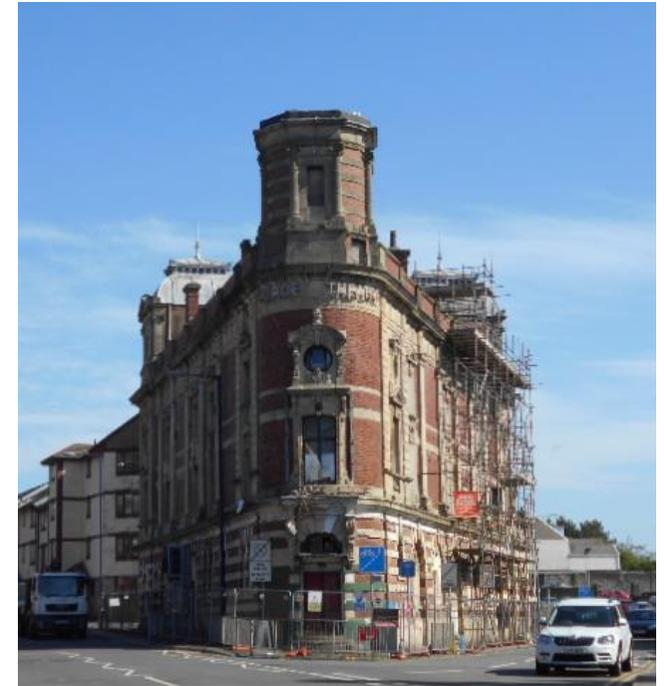
| <b>Name</b> | Palace Theatre |

| <b>Current Condition and use</b> | Urgent works to remove vegetation and repair masonry and roof completed in 2015<br>Interior is badly affected by dry rot and water ingress |

| <b>Current situation/ action needed</b> | Ongoing discussions with owner to ensure sustainable reuse of the building.<br>Level of risk reduced following completion of urgent works |

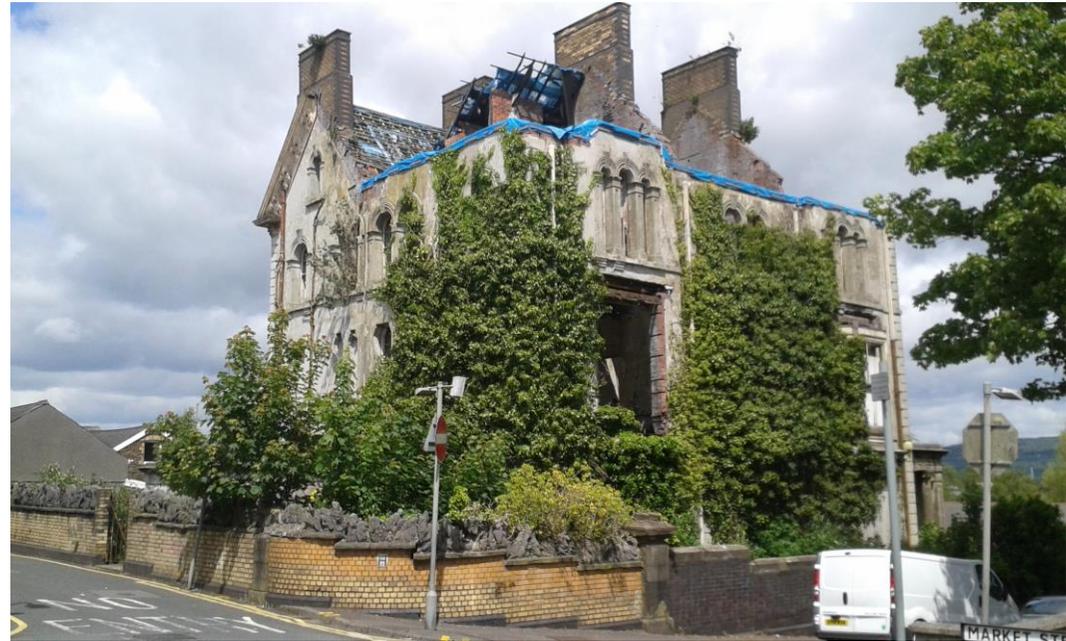
| <b>Name</b> | Danbert House<br>(also known as Dunbar House) |

| <b>Current Condition and use</b> | Roofless, significant vegetation established on building. Devoid of internal features.<br><br>Emergency partial demolition of chimneys and southern gables undertaken due to safety concerns<br><br>Enforced sale to new owner |

| <b>Current situation/ action needed</b> | Pre-applications discussions for conversion to flats |

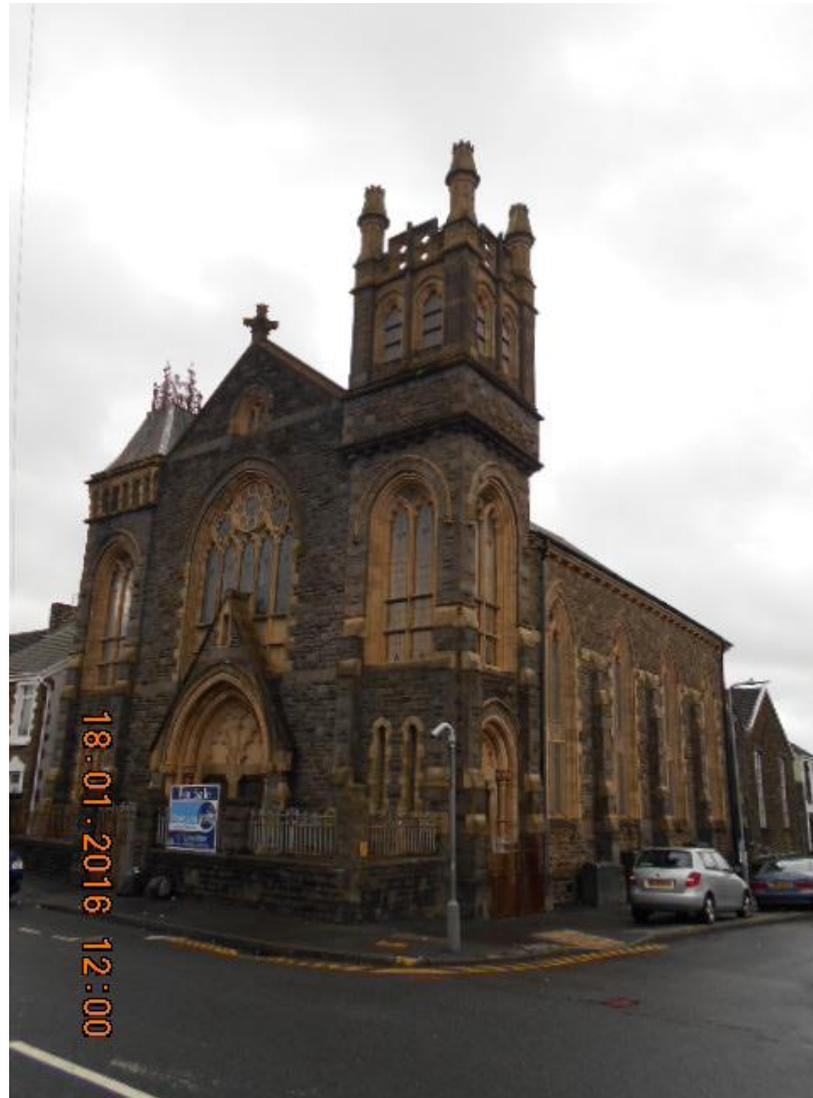
| <b>Name</b> | Brynhyfryd Chapel |

| <b>Current Condition and use</b> | Chapel closed and sold<br>Permission granted in 2014 for conversion to children's nursery and removal of pews.<br>Sunday school to rear affected by dry rot |

| <b>Current situation/ action needed</b> | Conversion to be implemented |

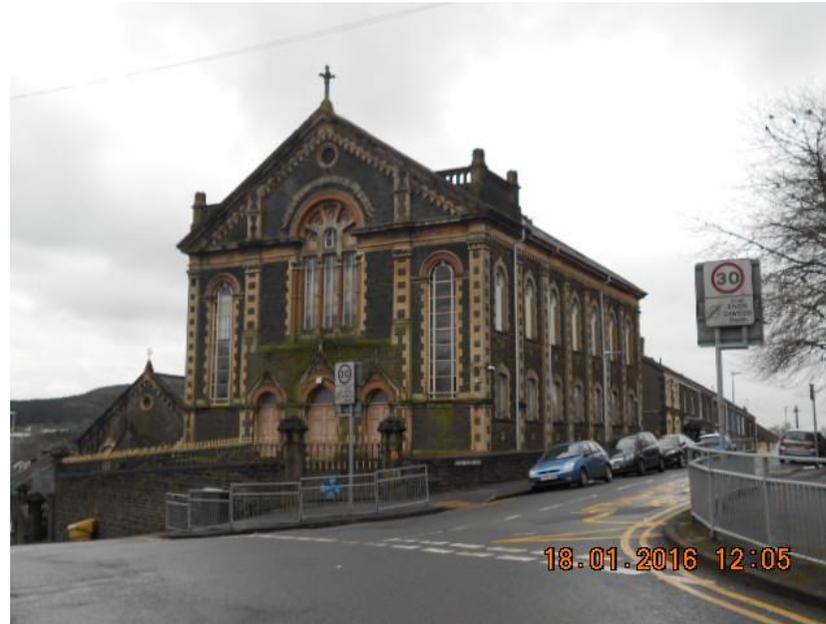
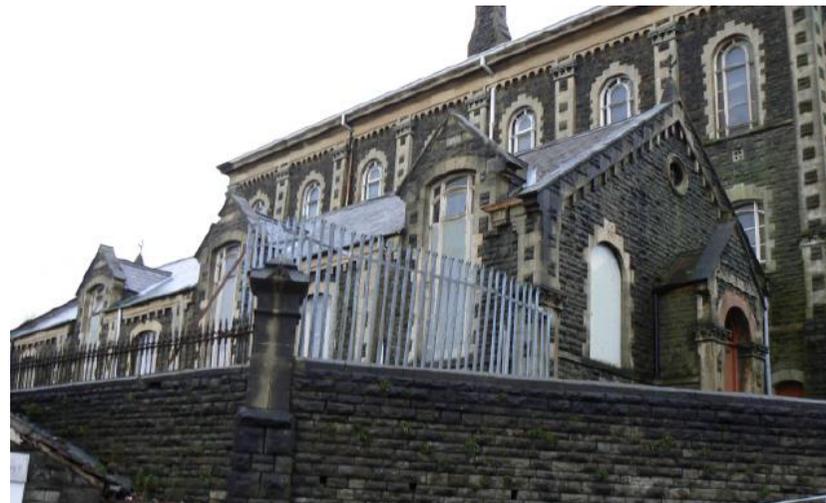
| <b>Name</b> | New Siloh Chapel |

| <b>Current Condition and use</b> | Chapel closed December 2015 and currently for sale<br>Main chapel is in good condition but attached lower level vestry hall (LB194) is significantly affected by dry rot. |

| <b>Current situation/ action needed</b> | Sustainable reuse required which respected the grade II* listing |

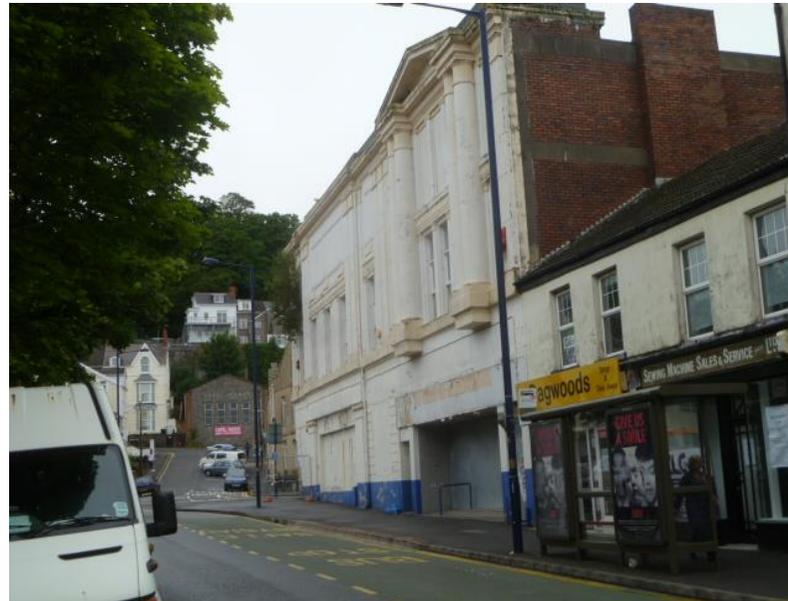
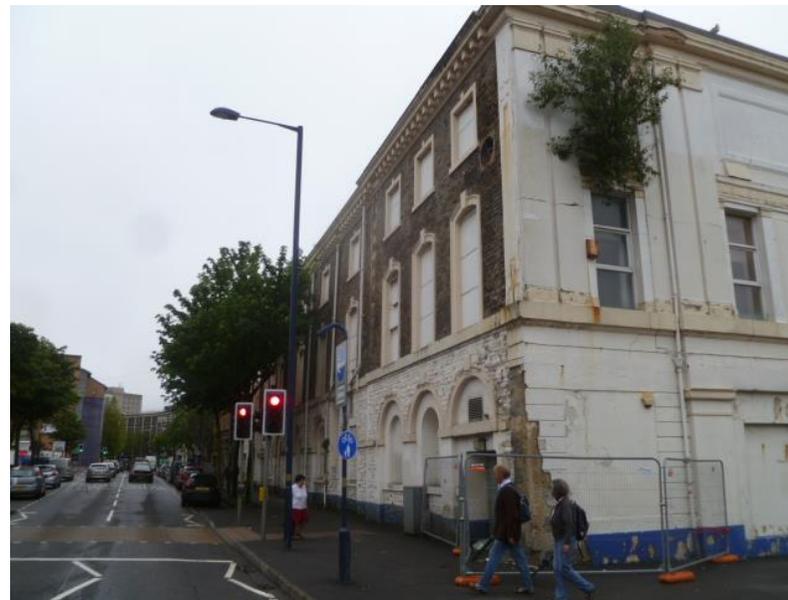
| <b>Name</b> | Albert Hall |

| <b>Current Condition and use</b> | Vacant since 2007. Weather tight, but starting to deteriorate.<br>Sold at auction during 2015 |

| <b>Current situation/ action needed</b> | Discussions needed about sustainable reuse |

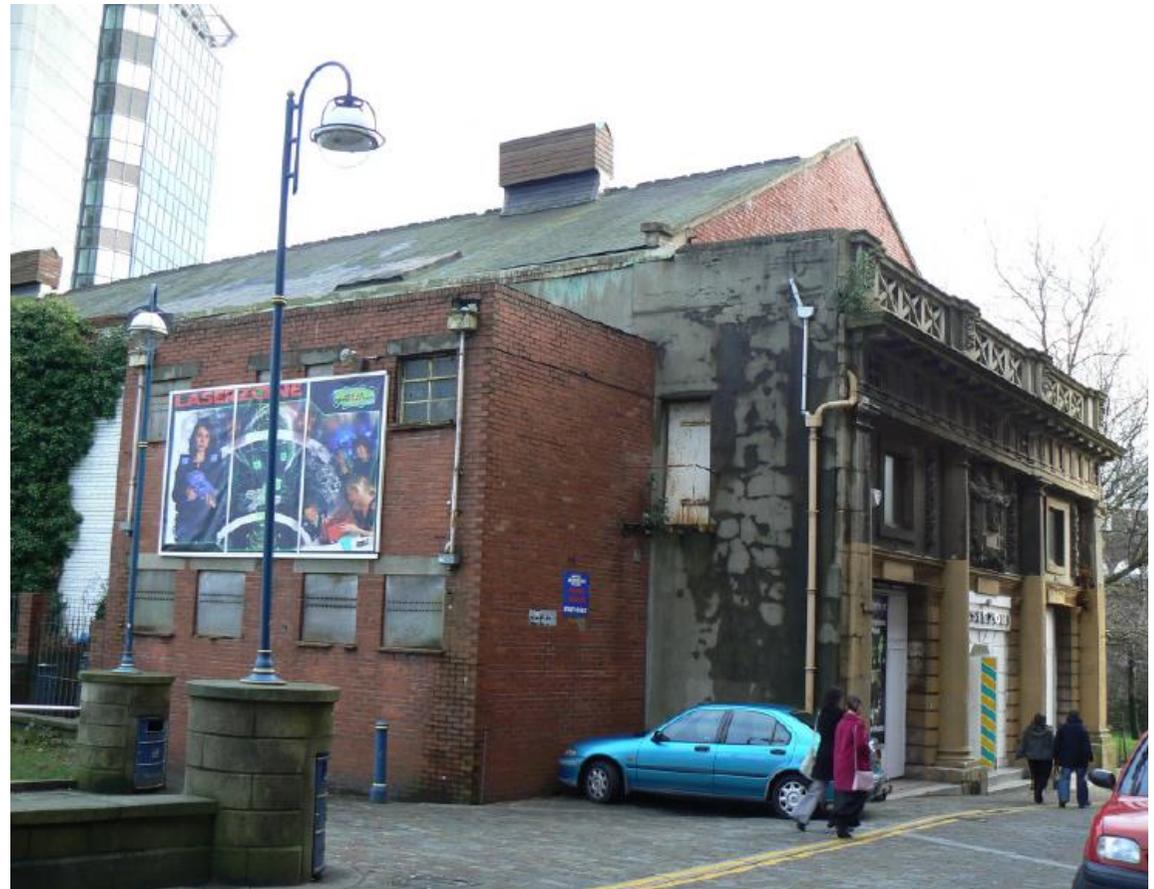
| <b>Name</b> | Castle Cinema |

| <b>Current Condition and use</b> | Lack of maintenance with vegetation becoming established on side walls and signs of cracking.<br>Applications for conversion to student accommodation being considered |

| <b>Current situation/ action needed</b> | Sustainable reuse required |

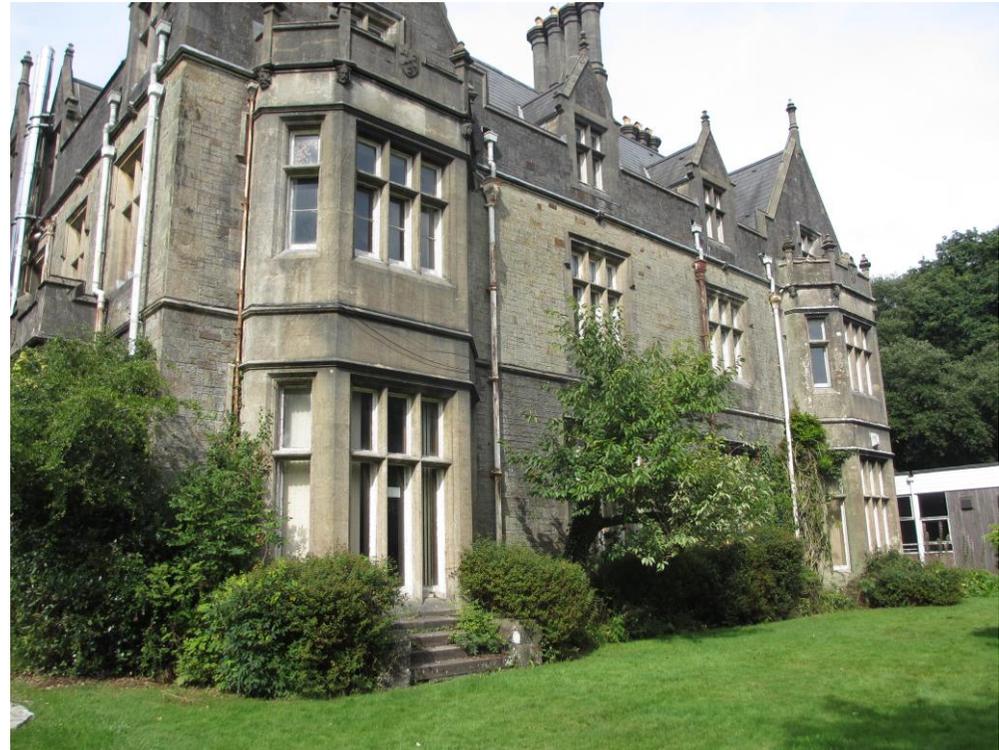
| <b>Name</b> | Hendrefolian House |

| <b>Current<br/>Condition and<br/>use</b> | Vacant and lack of<br>maintenance<br>Dry rot spreading internally<br>and has been subject to<br>break ins |

| <b>Current situation/<br/>action needed</b> | Occasional maintenance<br>undertake, but dry rot<br>spreading.<br>Sustainable reuse required.<br>Level of risk increased due<br>to spread of dry rot which is<br>threatening the interior |

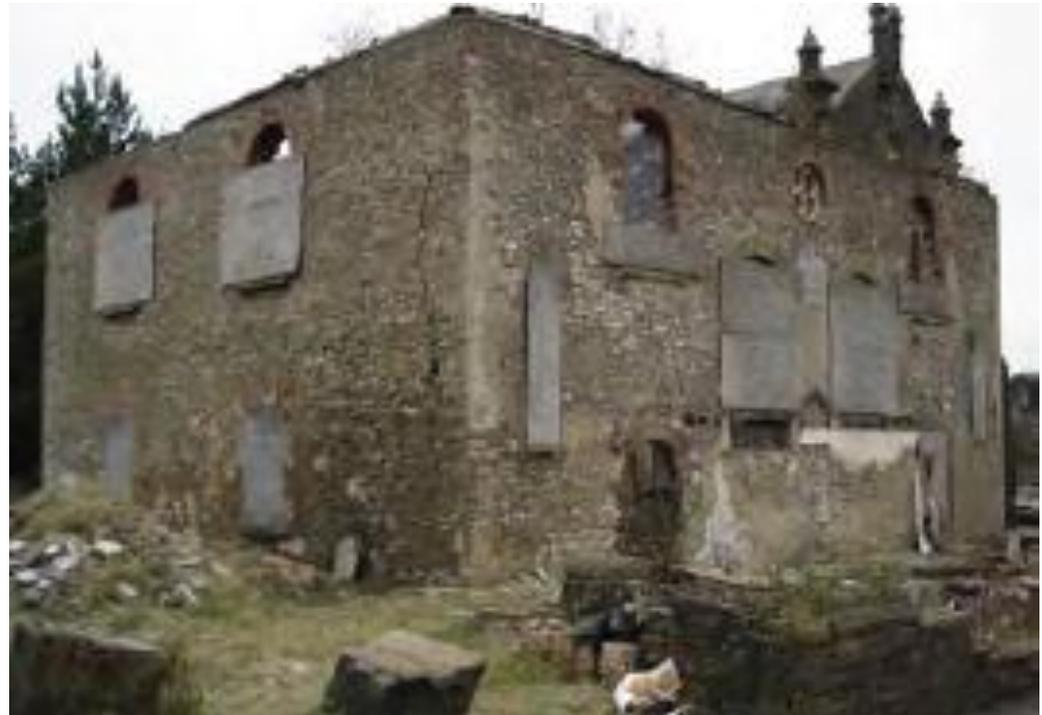
| <b>Name</b> | Capel Salem (Capel y Cwm) Old Chapel |

| <b>Current Condition and use</b> | Fire damaged. Standing walls only. No internal features, windows or roof. |

| <b>Current situation/ action needed</b> | Listed Building Consent for residential conversion to 8 flats expired on March 2013.<br><br>No work since 2013 |

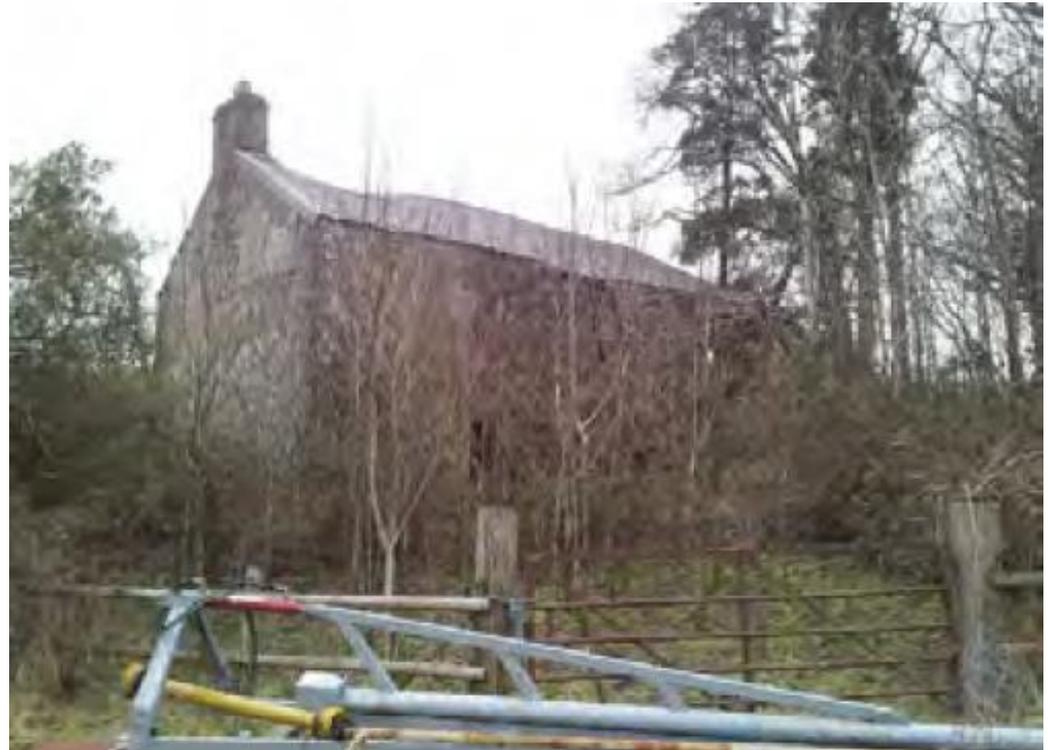
| <b>Name</b> | Allt-y-fanog |

| <b>Current<br/>Condition and<br/>use</b> | Isolated rural location.<br>Long running lack of<br>maintenance.<br>Timber lintels have rotted<br>away and stonework has<br>partially collapsed |

| <b>Current situation/<br/>action needed</b> | Potential for reuse as a<br>'heritage holiday let'<br>No work since 2013 |

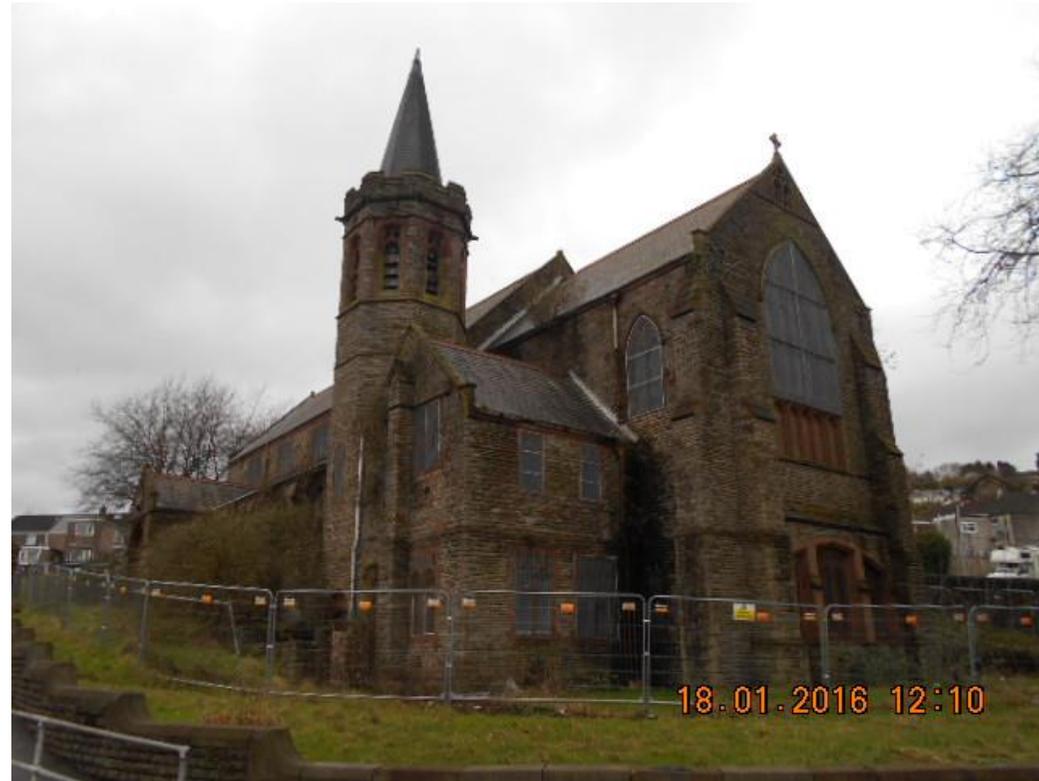
| <b>Name</b> | St Pauls Parish Church |

| <b>Current<br/>Condition and<br/>use</b> | Lack of maintenance.<br>Sold by church and now<br>vacant – proposals for<br>conversion to flats.<br>Building deteriorating due to<br>areas of water ingress |

| <b>Current situation/<br/>action needed</b> | No proposals at present. |

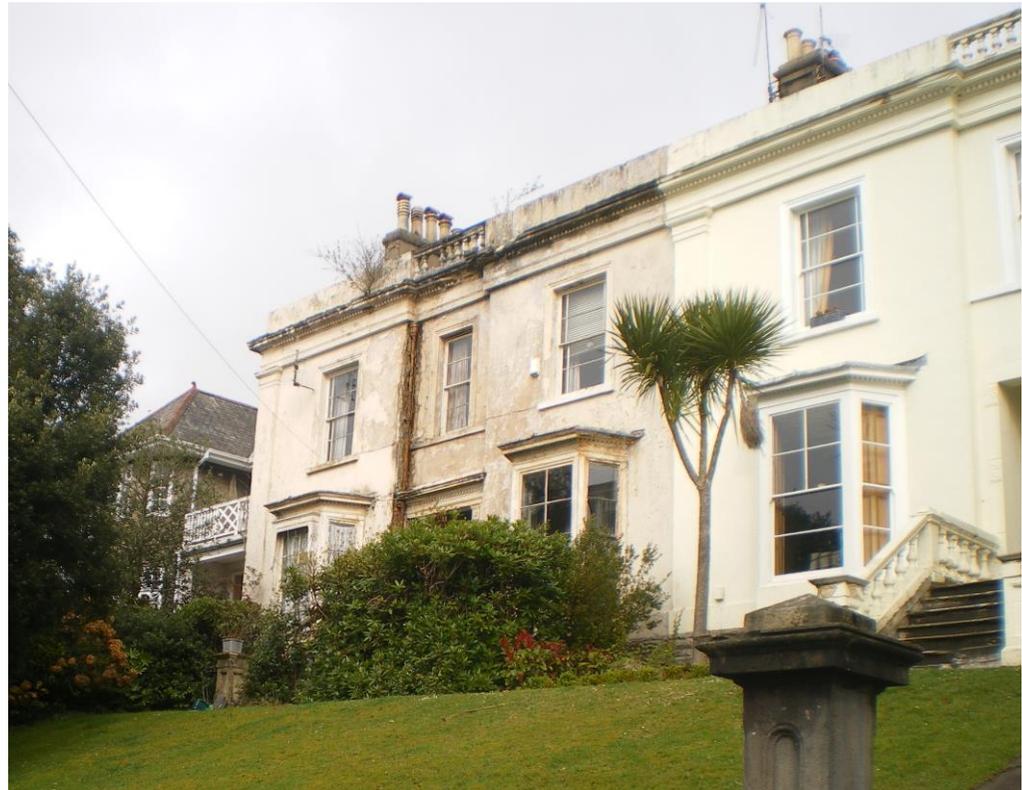
| <b>Name</b> | 4. Devon Terrace, Ffynone |

| <b>Current Condition and use</b> | Still in residential use.<br>Lack of maintenance.<br>Urgent works undertaken during 2015 to make balustrade and render safe |

| <b>Current situation/ action needed</b> | Risk grade increased due to further deterioration and partial occupation |
