# Beryl Road Section 19 Flood Investigation - Storm Dennis

## Section 19 Investigation Report

Swansea Council

5200249-10-DG-001

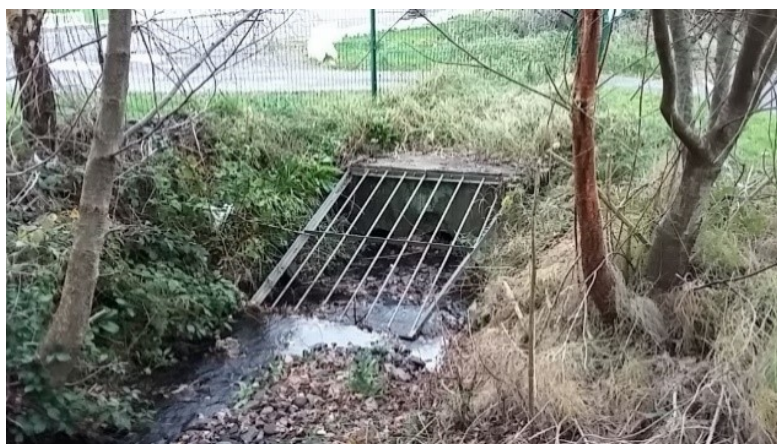
**Figure 3-2 – Screen and headwall on short culvert under the Cricket Club access from Park Road/ Waverley Close.**

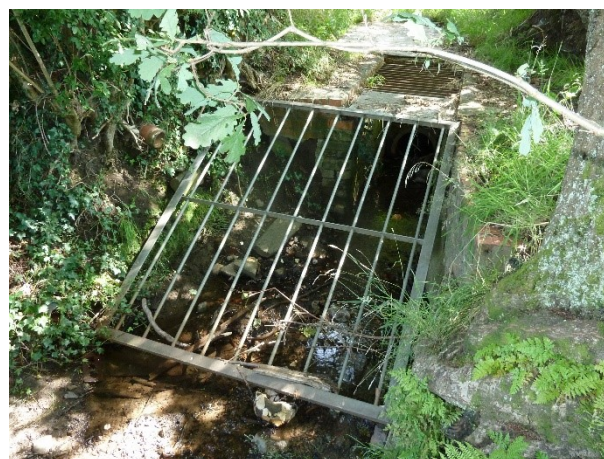
**Figure 3-5 – Screen at entrance to long culvert into Enid Road adjacent to the cricket pavilion.**

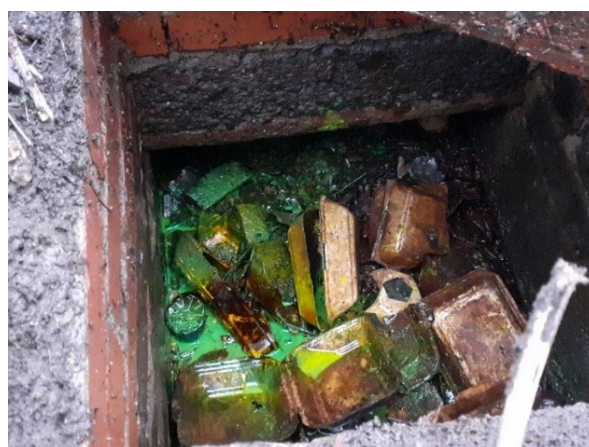
As part of this investigation a chamber was identified near the ditch in an area of overgrown scrub south of No. 18 Capel Road (see Figure 3-8 and Figure 3-12). The route from this chamber to the stream was determined through dye tracing. Although the outlet position could not be located, the dye was observed to emanate into the stream at the location indicated on Figure 3-12 and is taken as evidence of a positive connection to the ditch.

**Figure 3-8 - Chamber rear of No. 18 Capel Road.**

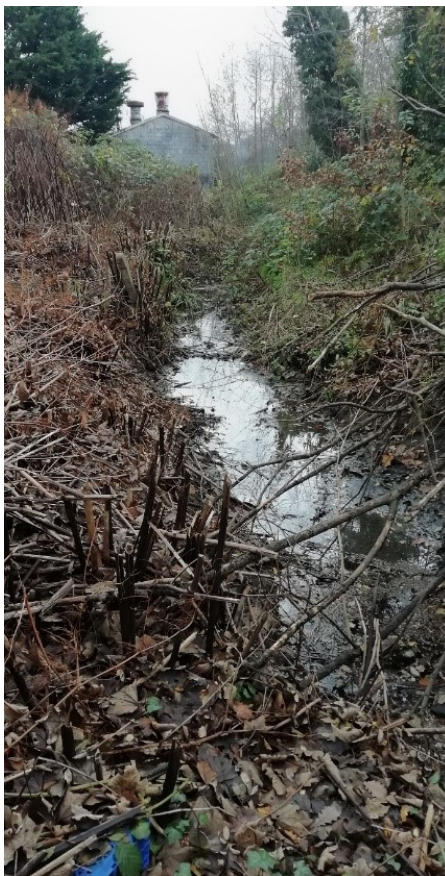
The course of the ditch runs south-west, parallel to Swansea Canal, before turning through approximately 90 degrees to cross under the canal in an inverted syphon.<sup>3</sup> The headwall to this syphon is shown in Figure 3-10. The poor condition of the ditch channel and the significant debris at the inlet to the inverted syphon are shown in figures Figure 3-9, Figure 3-10 and Figure 3-12 below.

**Figure 3-9 – Ditch channel upstream view from syphon inlet north of the Canal.**

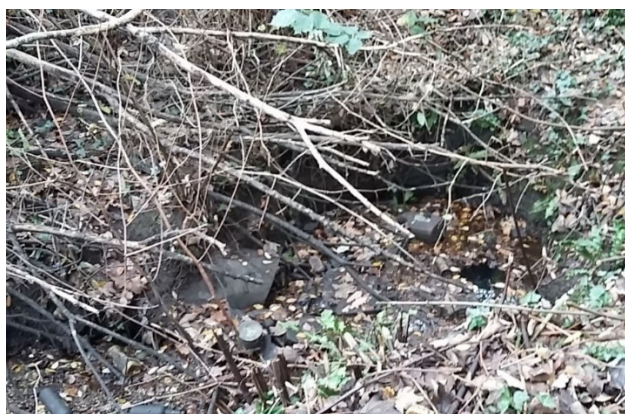
**Figure 3-10 – Headwall/ inlet to inverted syphon south of the canal (dye trace visible).**

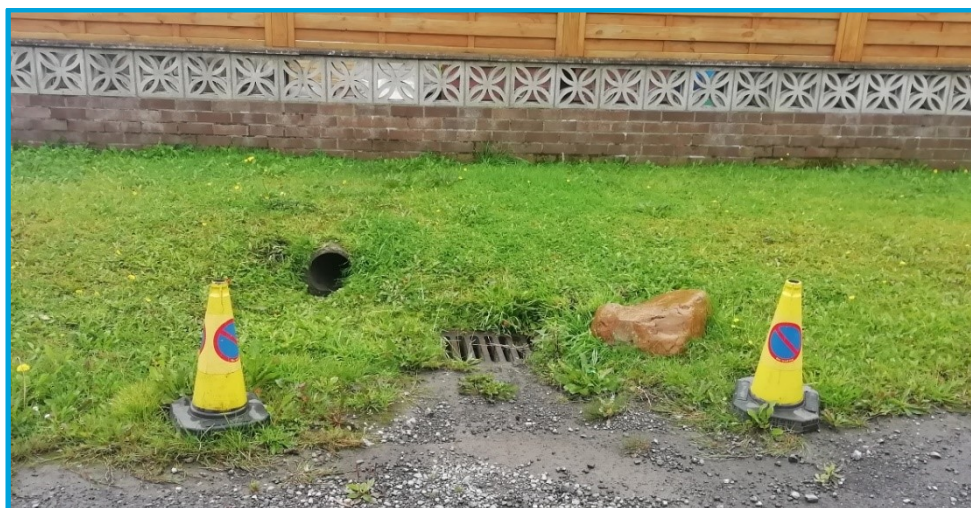
From enquires with residents and DCWW it is understood that in addition to property connections, a road gully and informal pipe inlet outside No.19 Beryl Road also connect highway runoff into this DCWW surface water sewer. These features were observed during a visit to the site, and they are illustrated in Figure 4-2.

**Figure 4-2 – Photograph of gulley and inlet outside No.19 Beryl Road.**

These non-standard connections would not normally be approved by DCWW, but it is understood from discussions with DCWW's representative that these connections were in place when DCWW became responsible for them, possibly at the privatisation of the water companies in 1989.

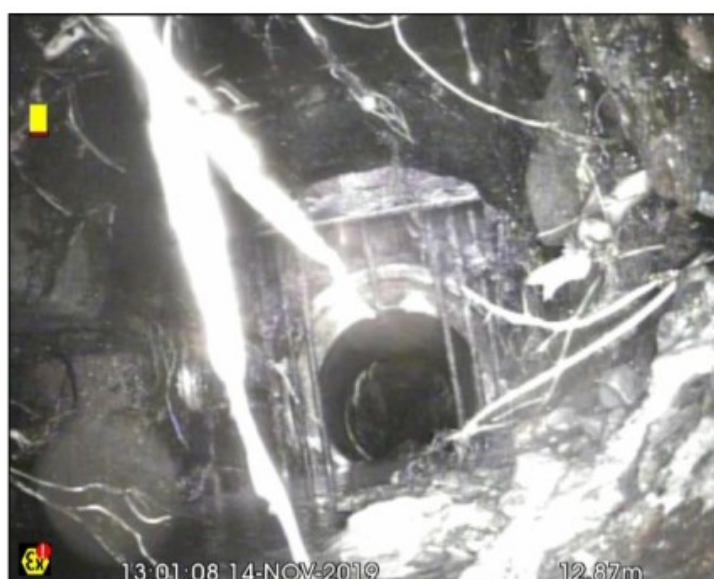
Photo: 1\_1\_21\_A.jpg  
2.87m, Finish node type, manhole reference number: SN69015509

The line was jet cleansed and roots that had penetrated the sewer were cut on 14<sup>th</sup> November 2019. This maintenance followed a flooding incident reported to have caused internal flooding to No. 17 Beryl Road (Fire Service callout records to Beryl Road indicate flooding on 2<sup>nd</sup> November 2019). The survey report quotes a pipe diameter of 300mm which is at variance to the 150mm shown on the sewer drawings. Also, the report illustrates the remnants of what appears to be an old screen (Figure 4-3) within the system which may contribute to blockages. The conduit appears to be rubble masonry construction of poor condition in this location.

**Figure 4-3 – Condition of chamber in Drill Hall Grounds (ref SN69015509) 14<sup>th</sup> November 2019 (picture provided by DCWW).**

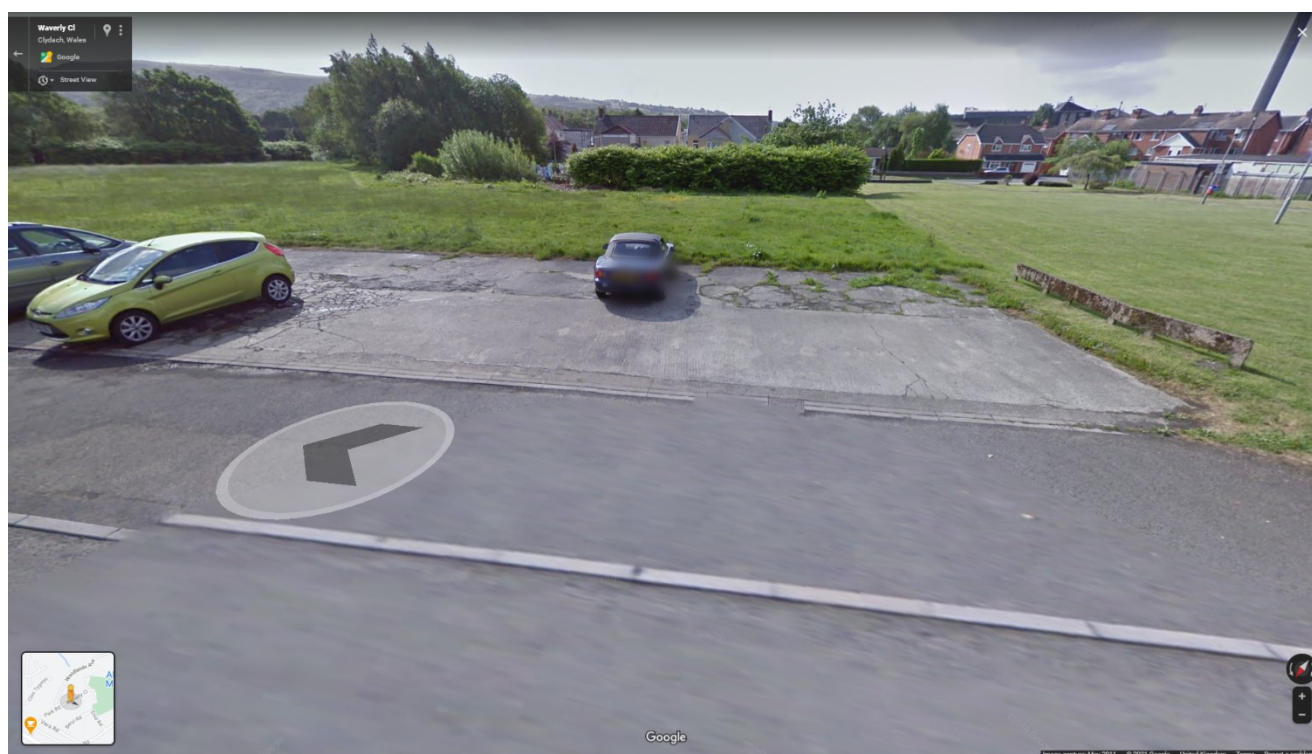
Runoff from Park Road contributes to overland flow paths and makes a significant contribution to the flooding at Beryl Road, as described in the following sections of this report. During a site visit on 18<sup>th</sup> December 2020, the slot drain serving the low-lying parking area on Park Road (refer to Figure 4-4) was observed to be completely silted up along the majority of its length. The connectivity of this drain with the main highway drainage has not been confirmed.

**Figure 4-4 – Parking area on Park Road north of Beryl Road. Slot drain is located at the interface between the concrete and tarmac surfaces.**

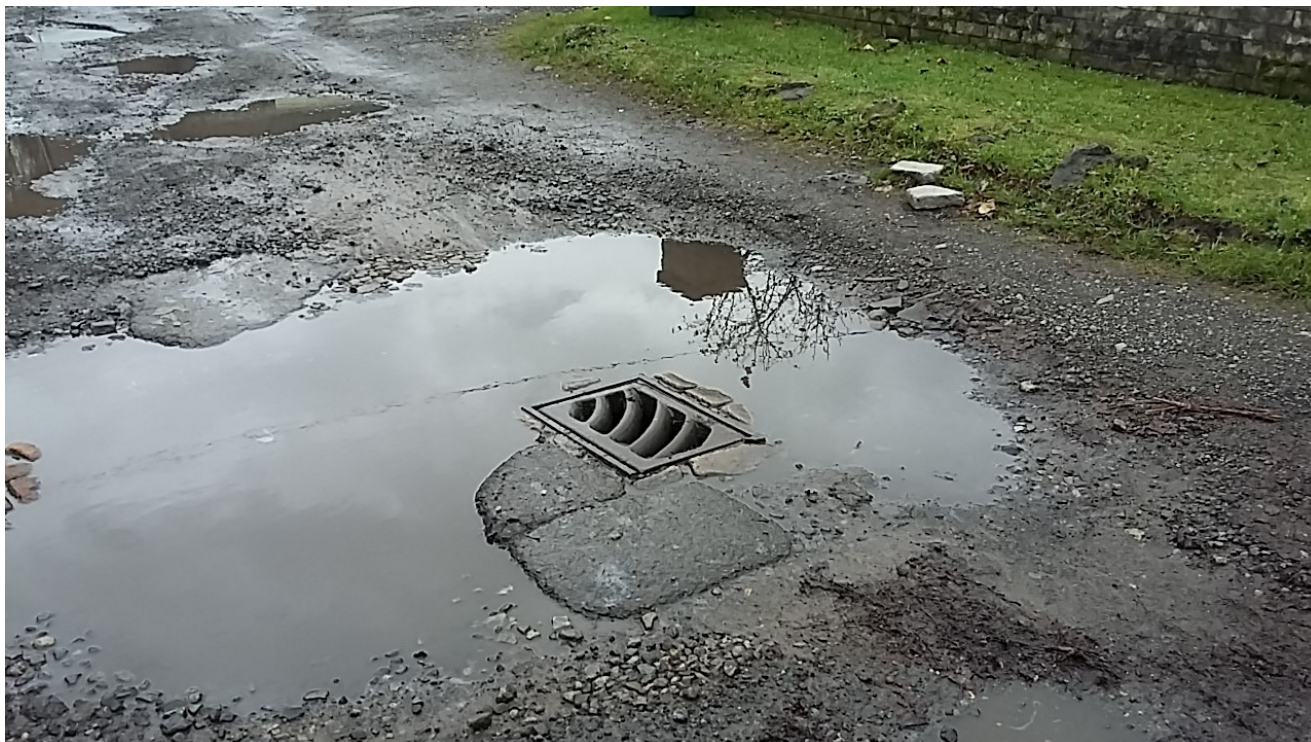
On Beryl Road itself, each of the four properties on the northern side has a single small gulley grating directly outside their boundaries. The discharge location is unclear but is assumed to be the DCWW surface water sewer. In addition to these property gullies, there are two additional large highway gullies (example shown in Figure 4-5) in the road with a connection to the DCWW surface water sewer.

**Figure 4-5 - Gulley in Beryl Road**

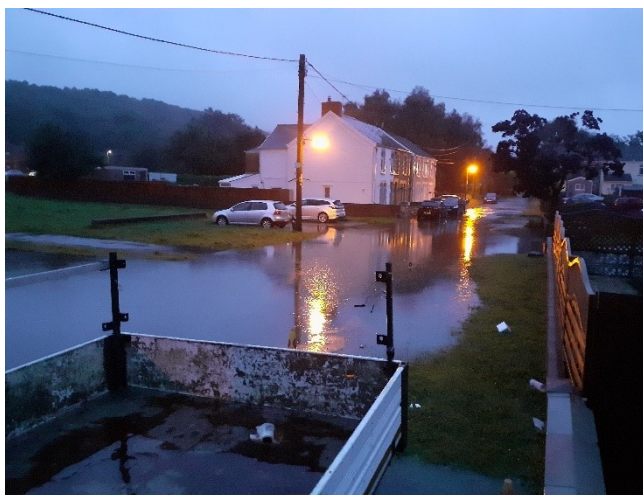
Extensive flooding affected Beryl Road during this event. Although water levels in the Enid Stream rose to the top of the cricket pavilion culvert inlet (Figure 5-3), no overland flow developed towards Beryl Road from this source. Water reportedly came up through the covers on the DCWW surface water sewer and ponded in the road. Overland flow from Park Road was also reported. Analysis of rainfall at NRW's nearby Trebanos rain gauge indicates that this was a 7 years return period event with 4 hours storm duration. The extent of flooding is shown by the following photographs provided by two of the residents.

**Figure 5-2 – Beryl Road – 25<sup>th</sup> August 2020, 06:02h.**

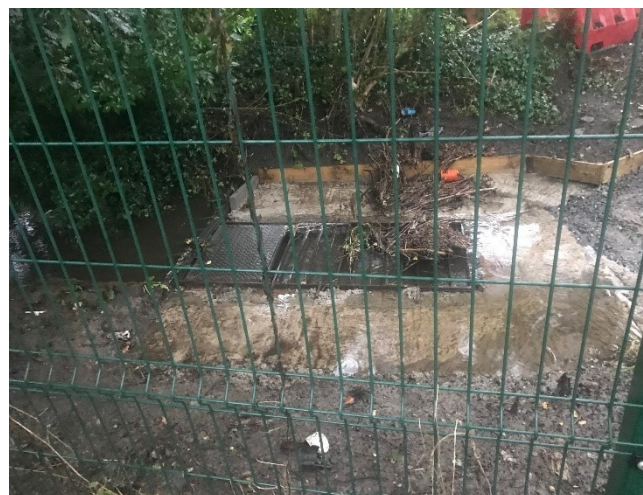
**Figure 5-3 – Culvert Inlet Cricket Pavilion, 25<sup>th</sup> August 2020, 06:51h.**

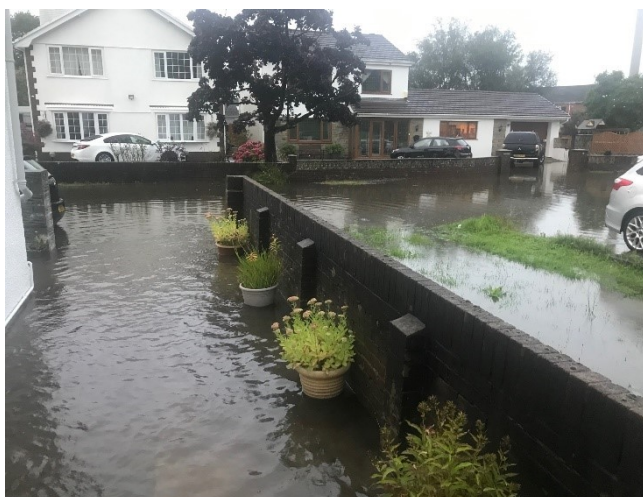
**Figure 5-4 – View from No. 20 Beryl Road on 25<sup>th</sup> August 2020.**

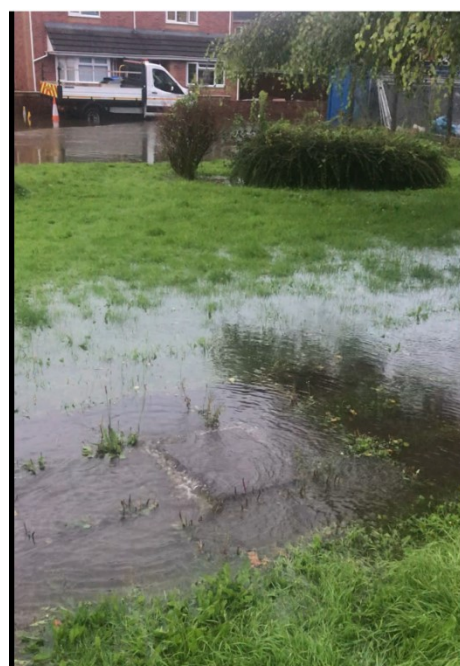
**Figure 5-5 – Water 'bubbling-up' from surface water cover at 06:45hrs (video still).**

- Water flooding from the top of the chamber on the DCWW surface water sewer in the green amenity area, between Park Road and Beryl Road (Figure 5-5, section 5.2 above), adding to overland flow onto Beryl Road.

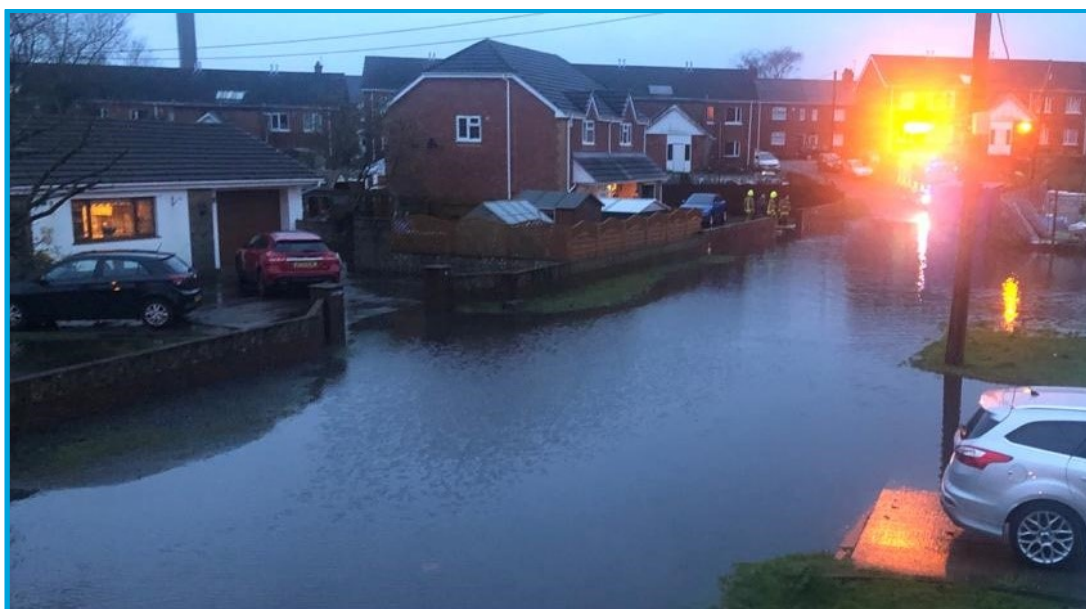
The main impact of the flood event was the inundation of Beryl Road itself and subsequent internal flooding of five properties along the road; the properties that suffered internal flooding were Nos.17, 20, 22, 24 and 26. The internal water depth observed by residents varies due to several factors, such as time of discovery and variations in individual property threshold levels, but they generally range from 5cm to 15cm (reported as 2 to 6 inches). In addition to these properties, the gardens of Nos.19, 21 and 23 were also flooded with depths ranging from 10cm to 60cm (4 inches to 2 feet). The peak of the flooding occurred during the early hours of the 16<sup>th</sup> February when many residents were asleep; consequently, there is no photographic evidence of the peak flood levels. However, Figure 6-3 shows the state of the road once residents awoke.

**Figure 6-3 – Flooding of Beryl Road, 16<sup>th</sup> February, after the peak.**

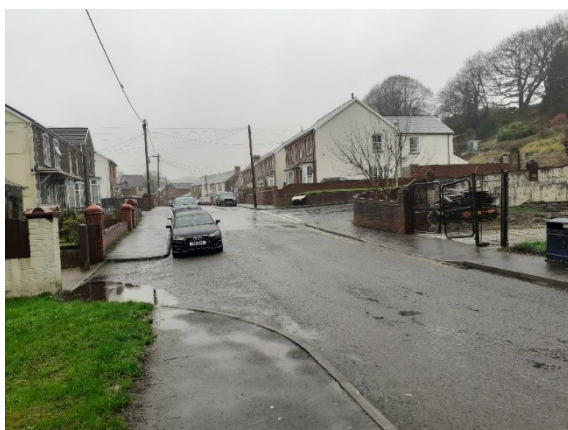
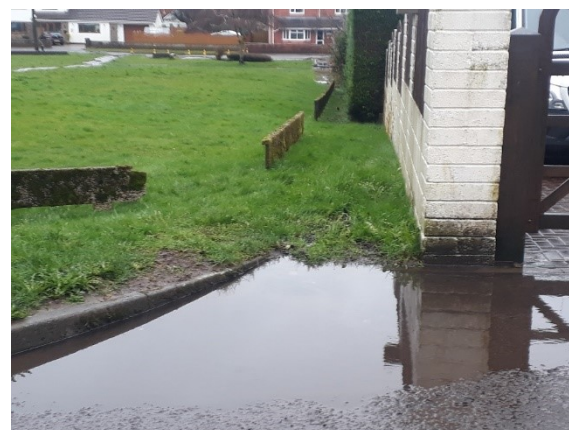
- Initial flooding on Beryl Road appears to have resulted from the gullies being unable to deal with surface runoff and therefore causing ponding at the low point outside No. 19 as well as in the localised depressions in the unmade road surface;
- Uphill from Beryl Road, the area around the highway gully outside No. 23 Park Road (location shown Figure 6-4) became inundated. Water levels here rose to overtop and spill over the kerb, resulting in an overland flow path developing across the green amenity area along the boundary with this property. This overland flow path was significant. Although no photos are available, this same flow path developed following heavy rain on 25<sup>th</sup> August 2020. The remnants of this path are shown in Figure 6-5.

Figure 6-4 – Ponding at gully at No. 23 Park Road (left) and view towards Nos. 19 and 17 Beryl Road (right).

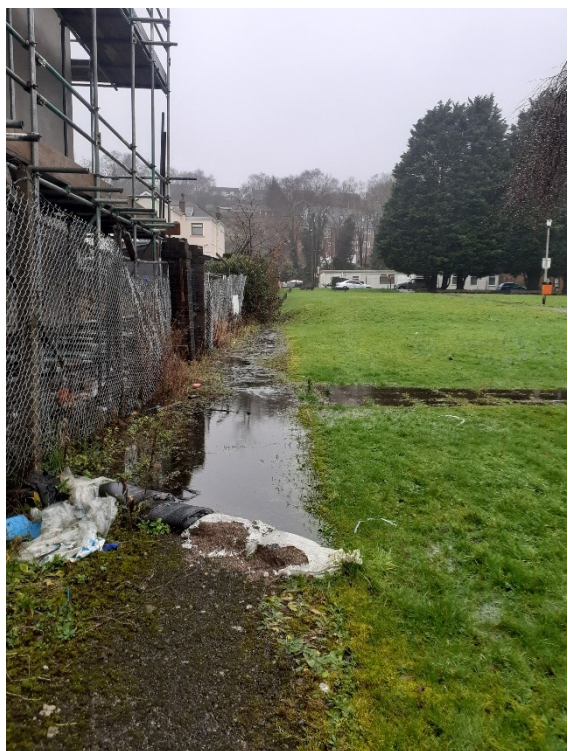
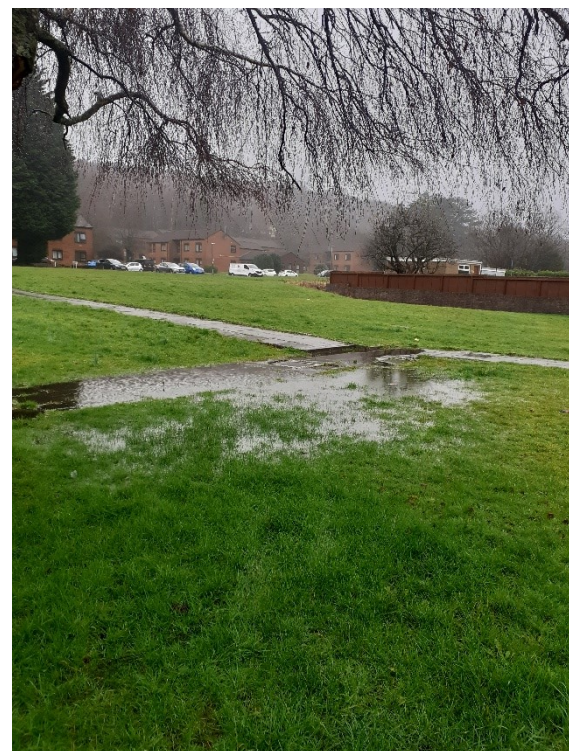
Figure 6-5 – Views of overland flow path looking upslope from Beryl Road towards Park Street.

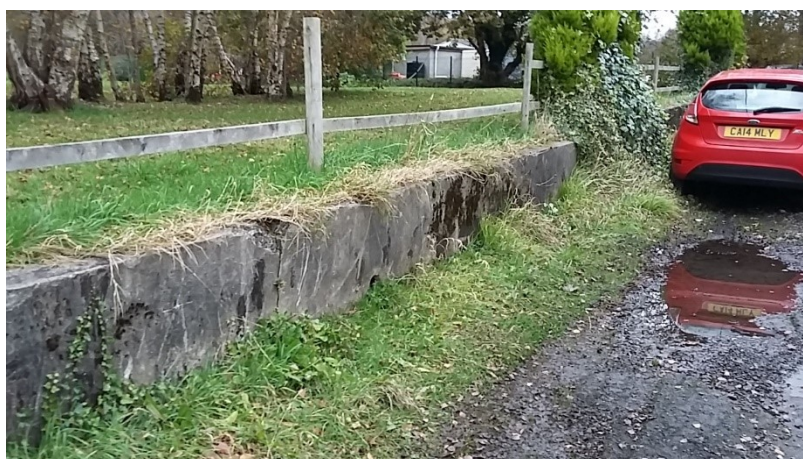
**Figure 6-6 – Water began to weir over this wall from the green amenity area east of No. 24 Beryl Road.**

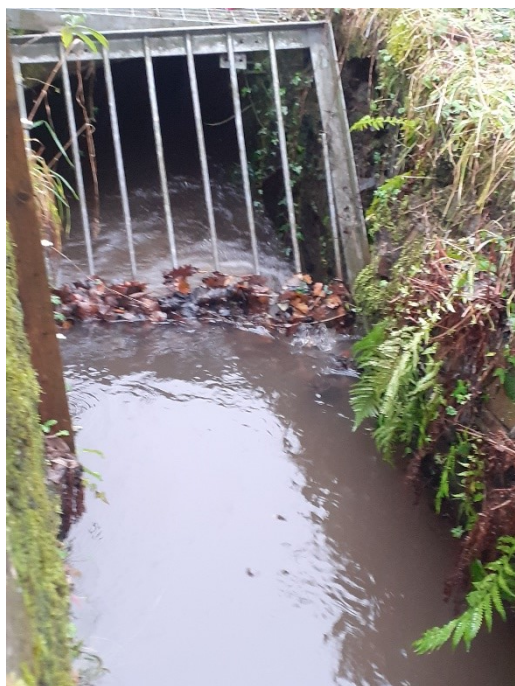
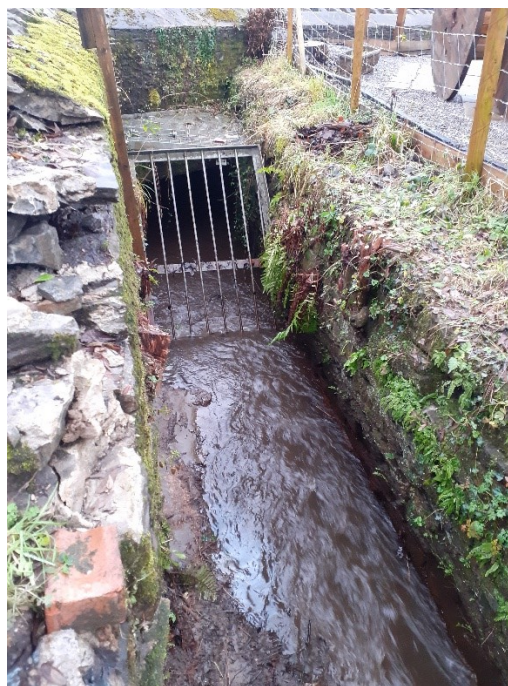
A resident has made the observation that during rainfall on 13<sup>th</sup> December 2020 clearance of debris from the screen at the B4603 Pontardawe Road (the “Men’s Shed”) resulted in a drop in water levels of approximately 250 to 300mm in the open channel downstream of the canal. This was reported to correlate with an observed drop in water levels at the cricket pavilion culvert entrance (OS NGR 269576, 201705) of a similar magnitude. This evidence may be useful for a subsequent hydraulic assessment of the Enid Stream to its canal outfall downstream of the Mond works culvert.

**Figure 6-7 – B4603 Pontardawe Road Screen illustrating reduction in water levels following screen clearance on 13<sup>th</sup> December 2020.**
