**City and County of Swansea**

**Building at Risk Register**

**Update 1 – May 2016**

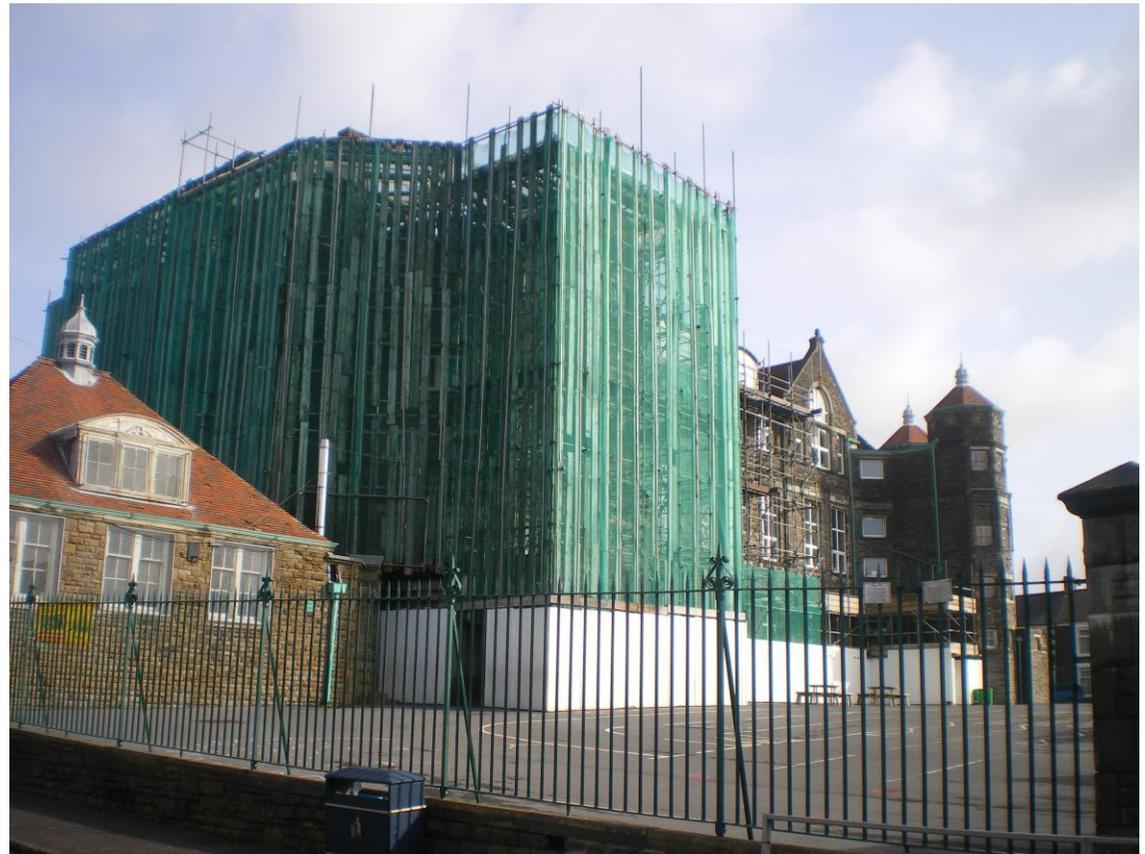
| <b>Current Condition and use</b> | Urgent works to remove vegetation and repair masonry and roof completed in 2015<br>Interior is badly affected by dry rot and water ingress |

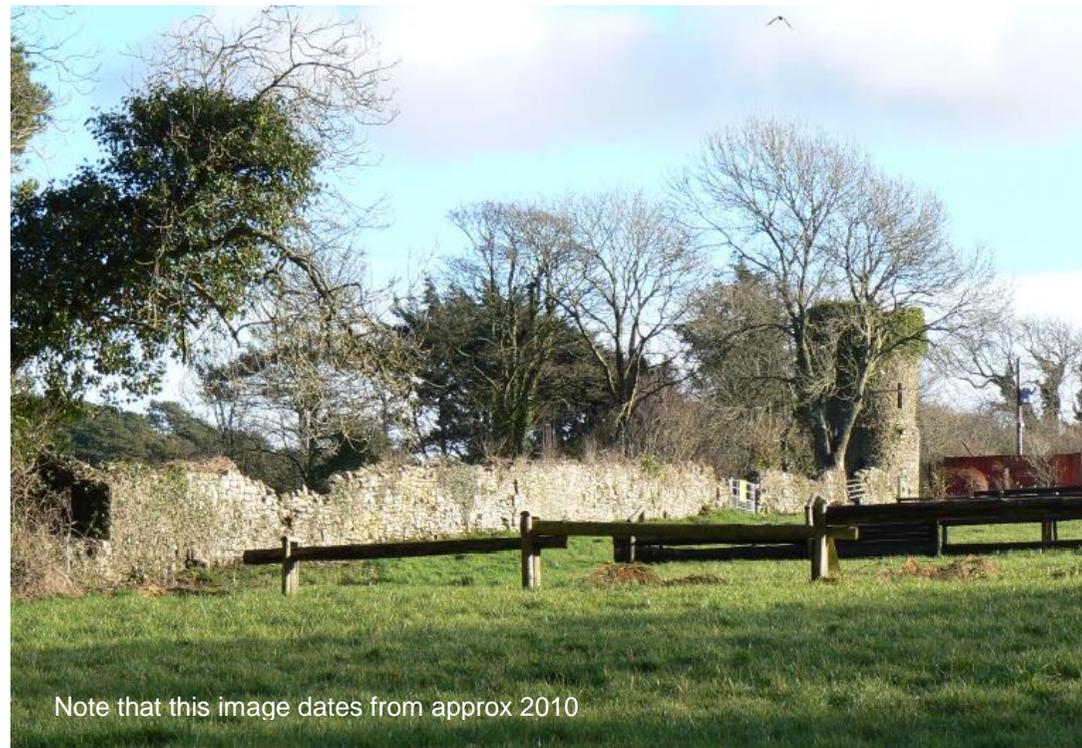
| <b>Current Condition and use</b> | Lack of maintenance |

| <b>Current situation/ action needed</b> | Building not in use. Listed building consent was granted (ref 2010/1704) for conversion to 12 apartments but this has not been implemented. Building currently for sale.<br>No work since 2013 |

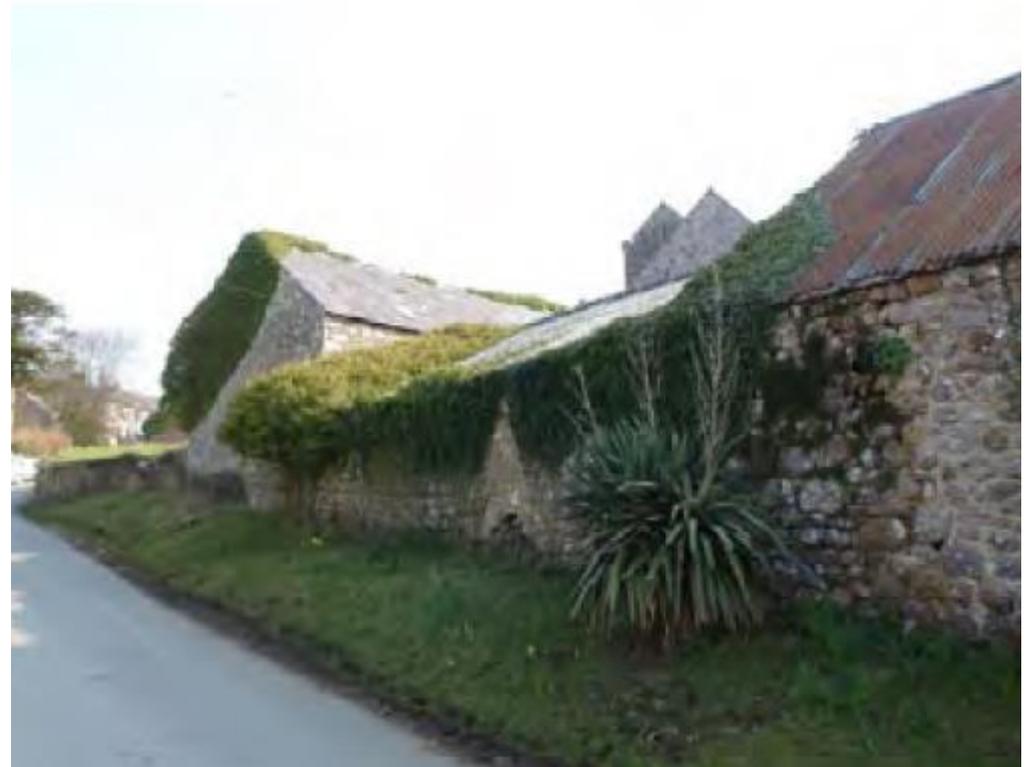
| <b>Current<br/>Condition and<br/>use</b> | Home to significant bat<br>roost of various species.<br>Sold by the Council in 2015 |

| <b>Current situation/<br/>action needed</b> | No proposals at present<br>No work since 2013 |

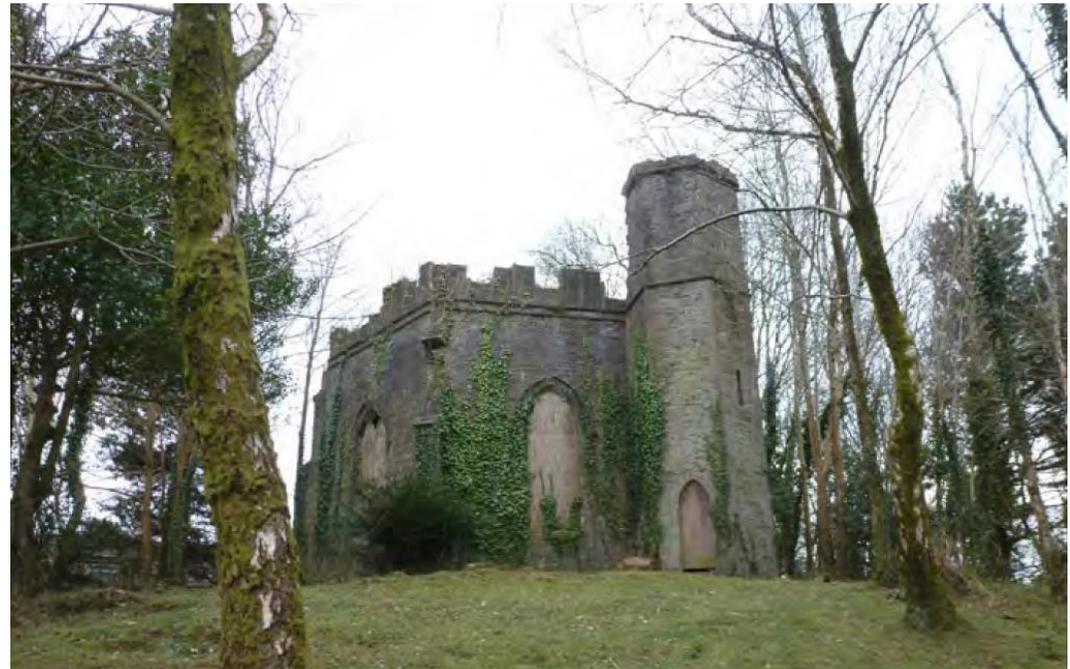
| <b>Current Condition and use</b> | Lack of maintenance |

| <b>Current situation/ action needed</b> | No proposals at present |

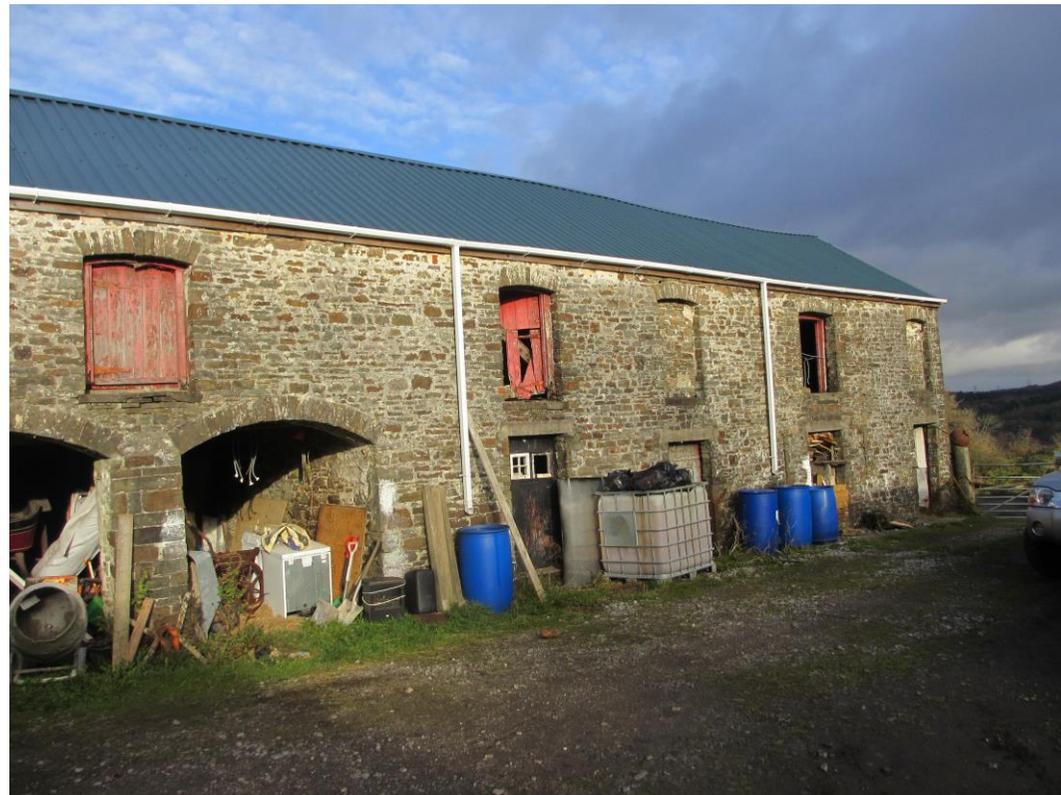
| <b>Current<br/>Condition and<br/>use</b> | Emergency partial<br>demolition undertaken 2011 |

| <b>Current situation/<br/>action needed</b> | Current Listed Building and<br>Planning applications to<br>partly rebuild ref 2011/1609<br>and 2011/1702 approved by<br>Area 2 Development<br>Control Committee in<br>October 2012 and ratified<br>by Cadw in November<br>2012.<br><br>No work since 2013 |

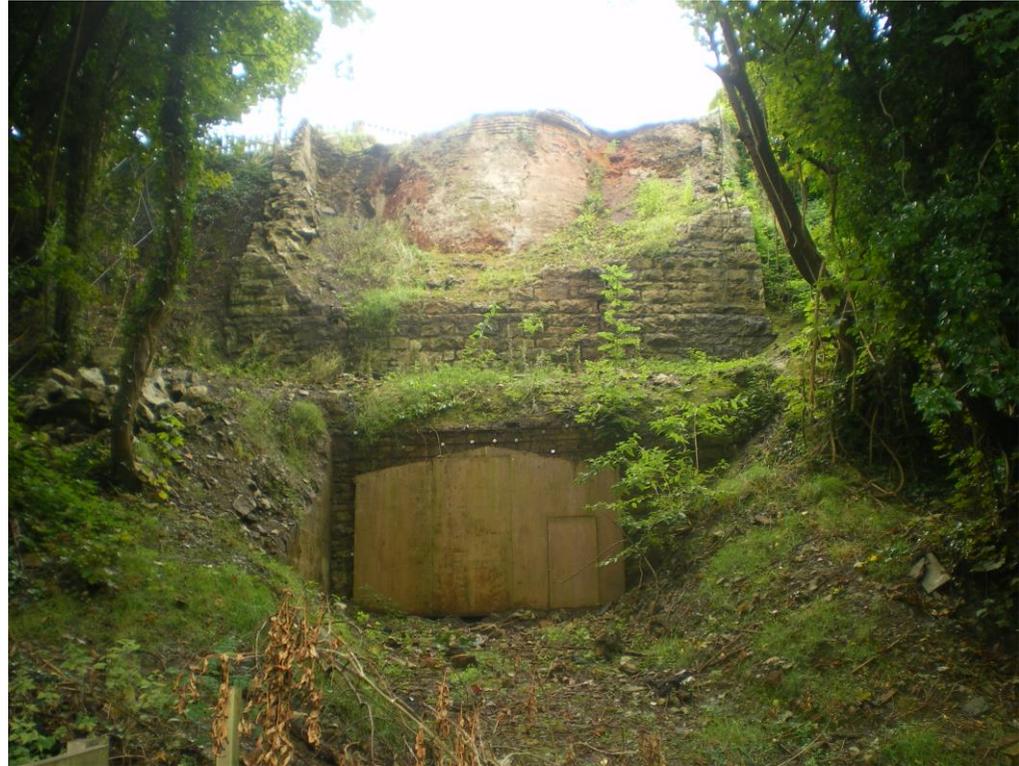
| <b>Current<br/>Condition and<br/>use</b> | Listed in a ruinous state |
| <b>Risk Grade</b> | 1 – Extreme Risk |

| <b>Current situation/<br/>action needed</b> | Potential to tackle with an<br>application for funding to the<br>Gower Historic Landscapes<br>Project (HLF)<br>No work since 2013 |

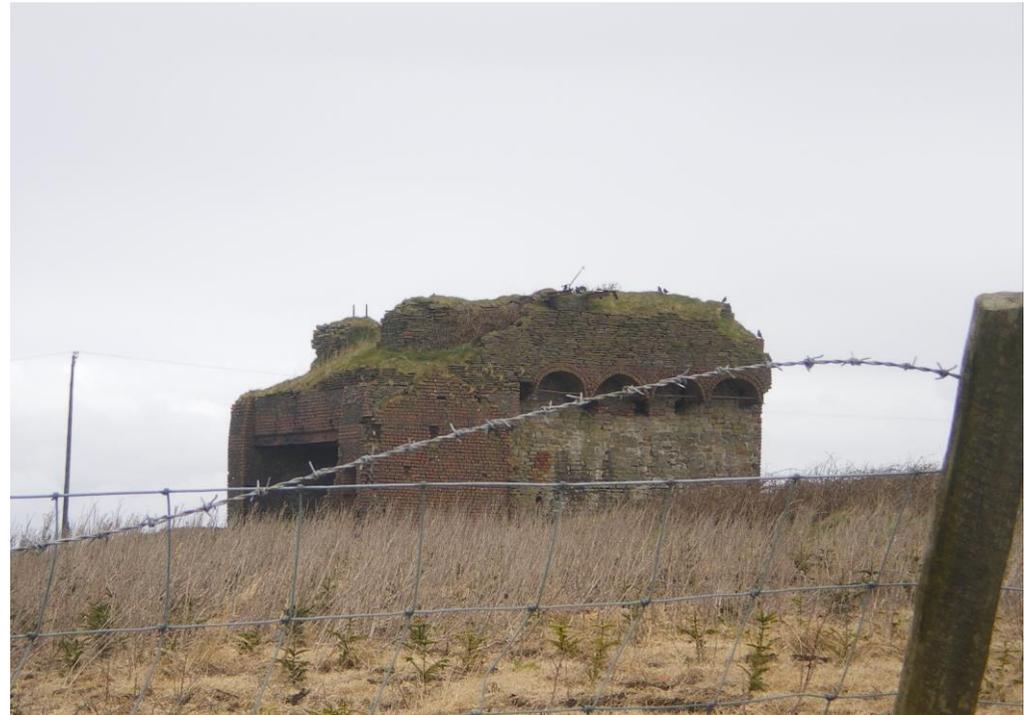
| <b>Current<br/>Condition and<br/>use</b> | Lack of maintenance |

| <b>Current situation/<br/>action needed</b> | Potential to tackle as<br>community project?<br>No work since 2013 |

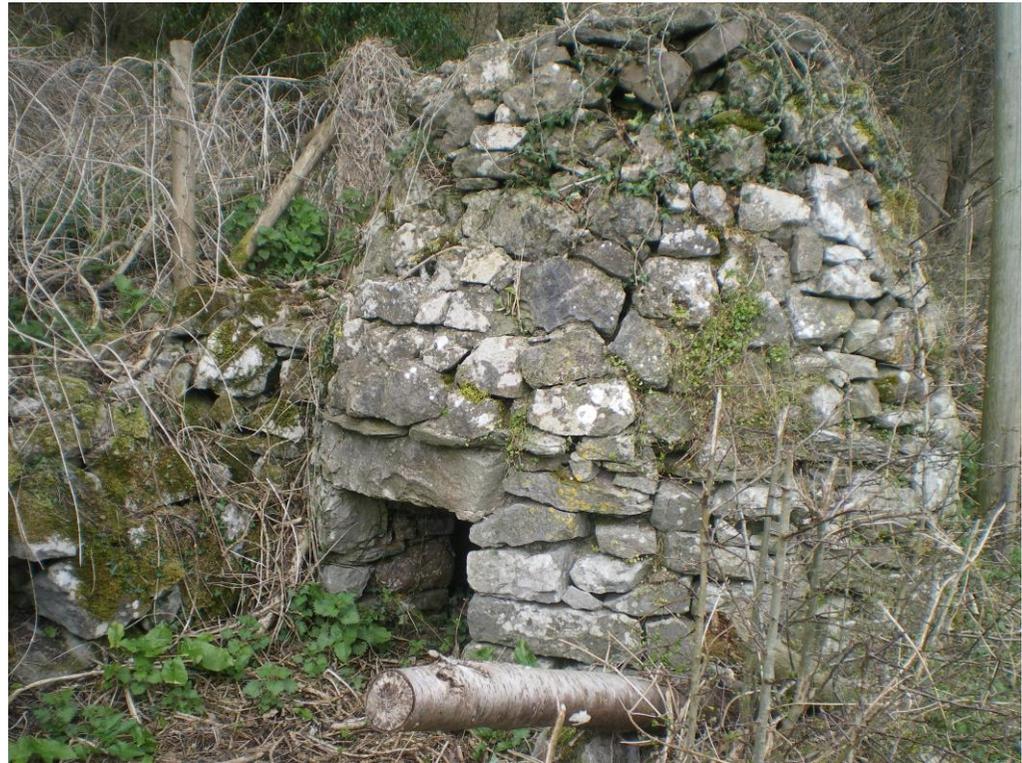
| <b>Current Condition and use</b> | Lack of maintenance |

| <b>Current situation/ action needed</b> | Potential to tackle through Gower Historic Landscapes Project (HLF)<br>No work since 2013 |

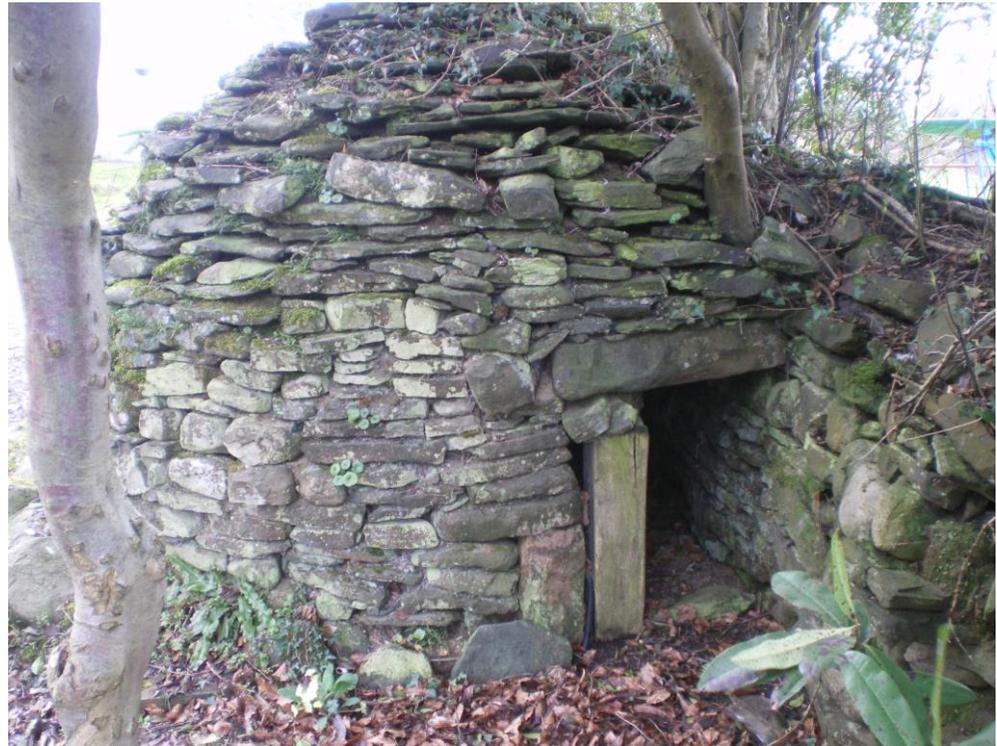
| <b>Current Condition and use</b> | Lack of maintenance and potential disruption by vegetation |

| <b>Current situation/ action needed</b> | Potential to tackle through Gower Historic Landscapes Project (HLF)<br>No work since 2013 |

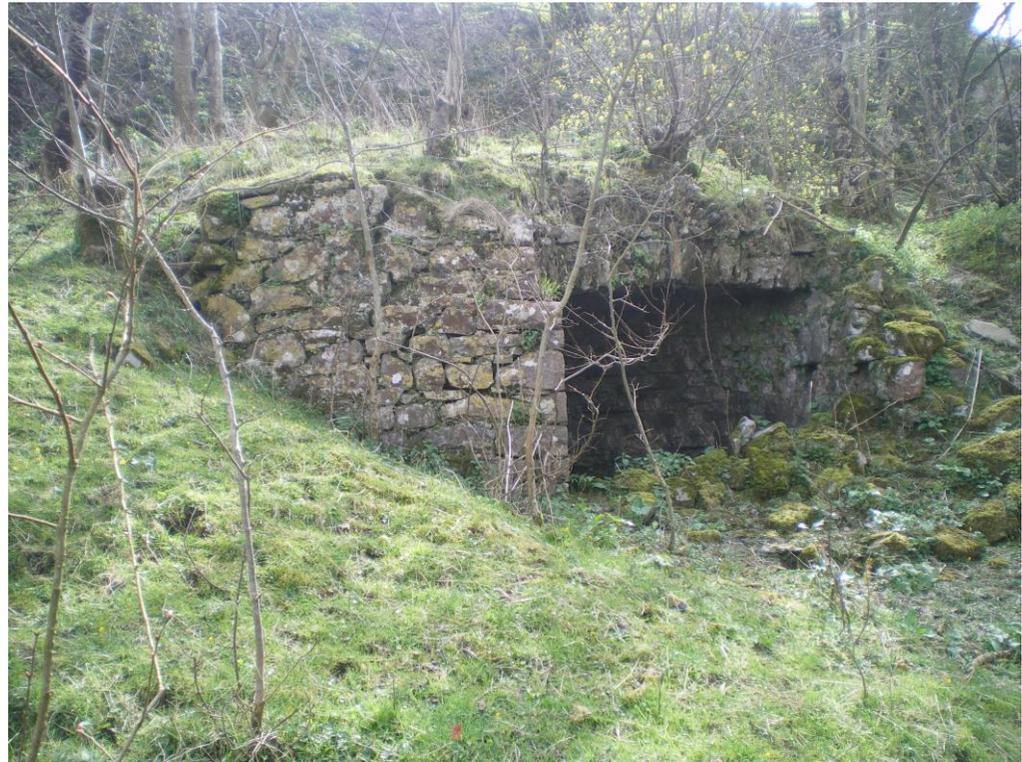
| <b>Current Condition and use</b> | Located in a Historic Park<br>Also a Scheduled Ancient Monument |

| <b>Current situation/ action needed</b> | Part of a programme of works at Penrice Castle which is being overseen by Cadw |

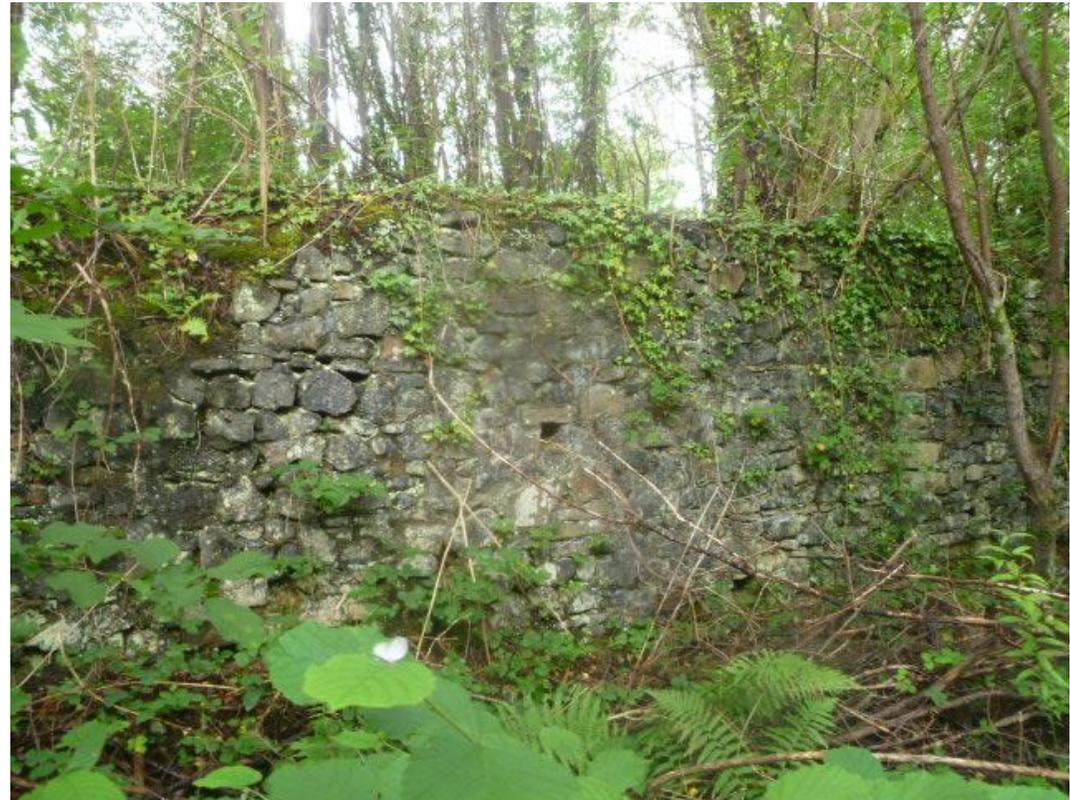
| <b>Current<br/>Condition and<br/>use</b> | Completely repointed and<br>reduced in height as part of<br>Morfa Road proposals. |

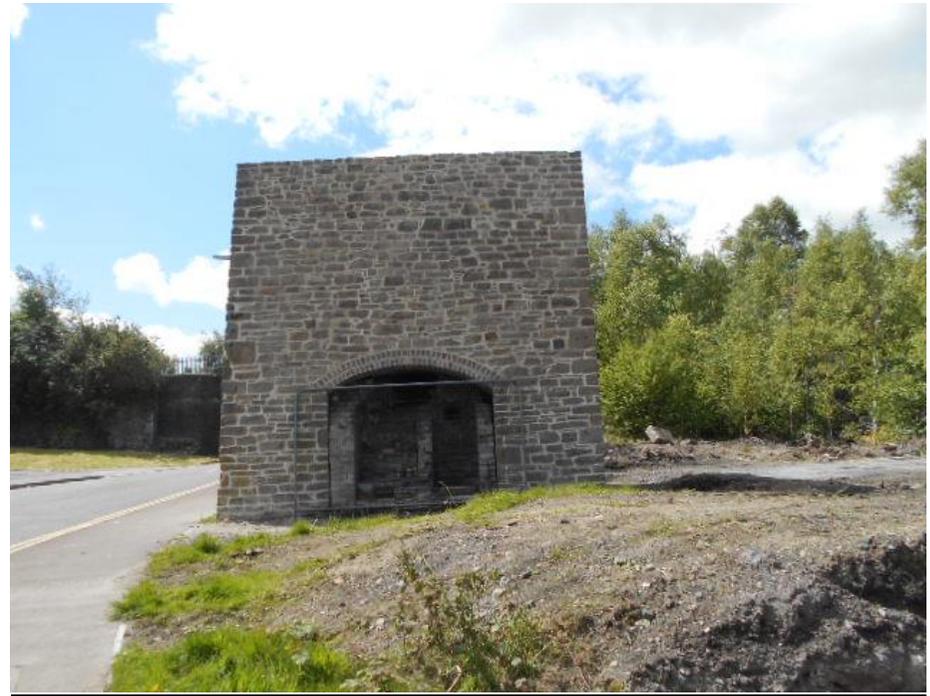
| <b>Current<br/>Condition and<br/>use</b> | The kiln has been<br>consolidated and repointed<br>as part of the Morfa Road<br>project. |

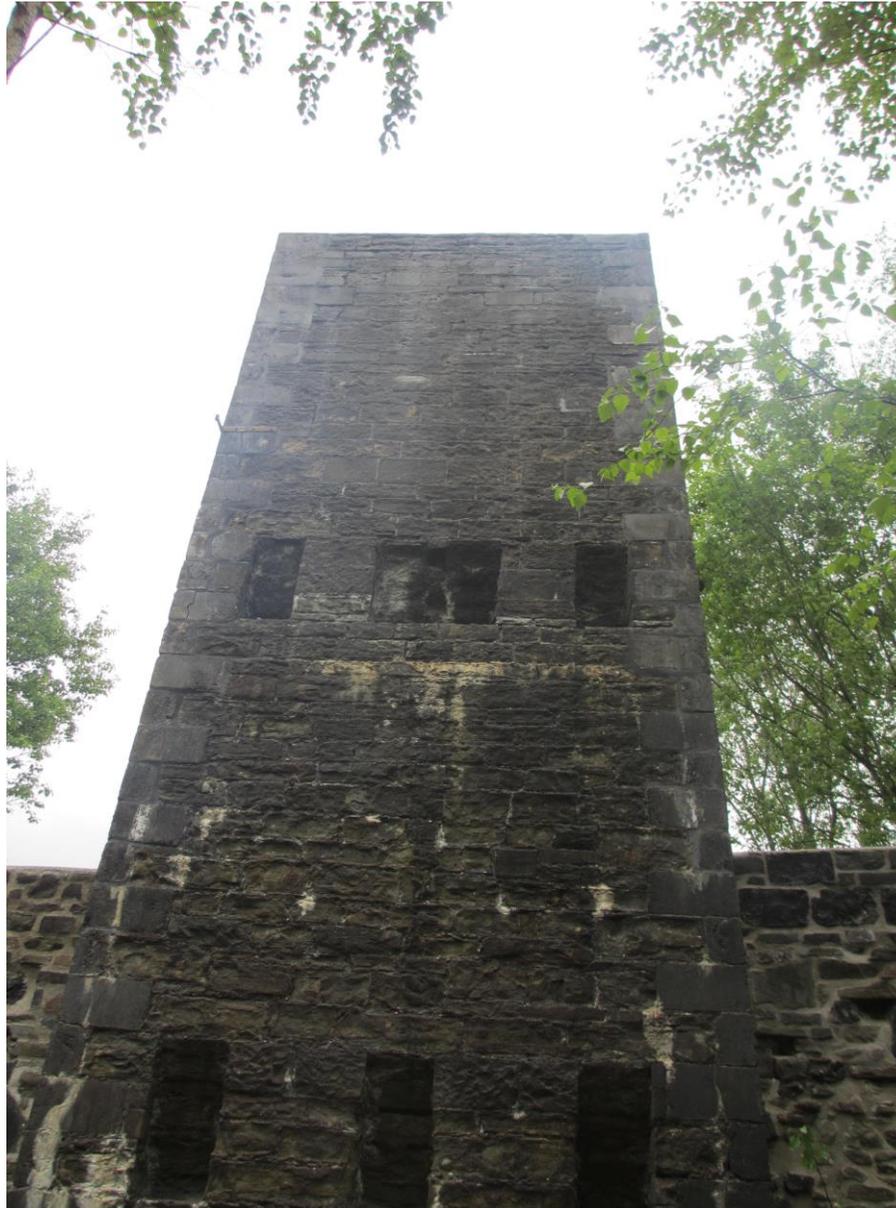
| <b>Current<br/>Condition and<br/>use</b> | Repaired and repointed |

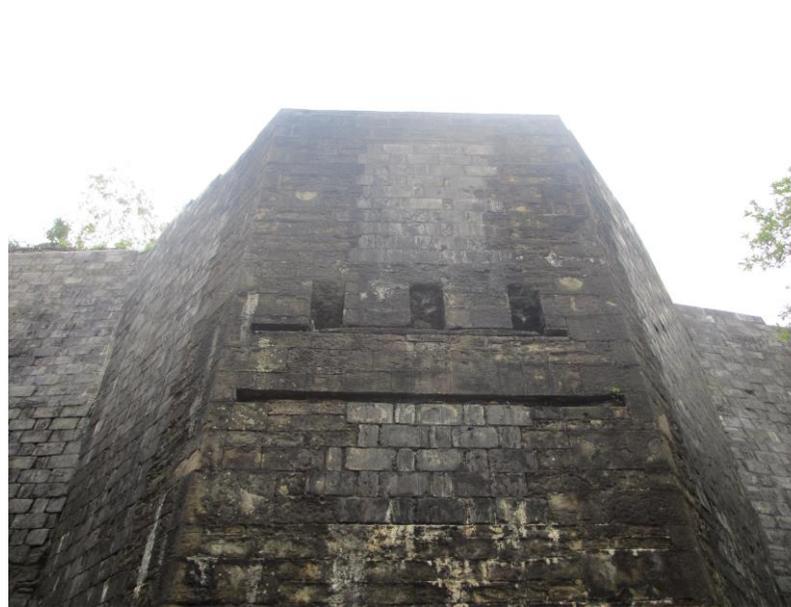
| <b>Current<br/>Condition and<br/>use</b> | Repaired and repointed |

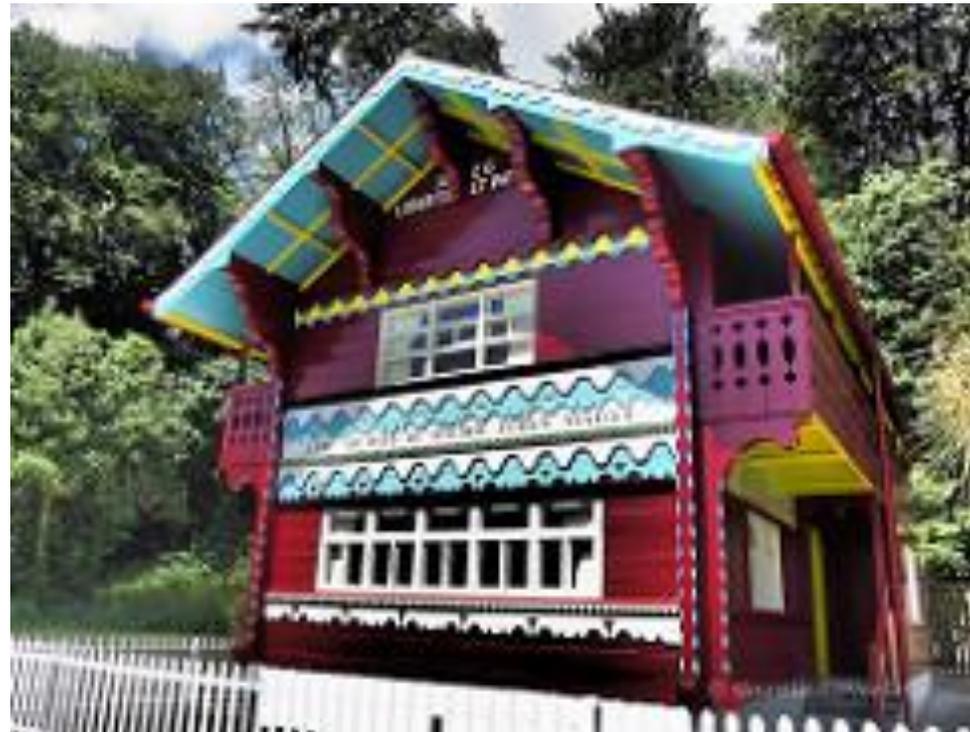
| <b>Current<br/>Condition and<br/>use</b> | Completely restored as<br>shell<br>Located in a Historic Park |
