# Beryl Road Section 19 Flood Investigation - Storm Dennis

## Section 19 Investigation Report

Swansea Council

5200249-10-DG-001

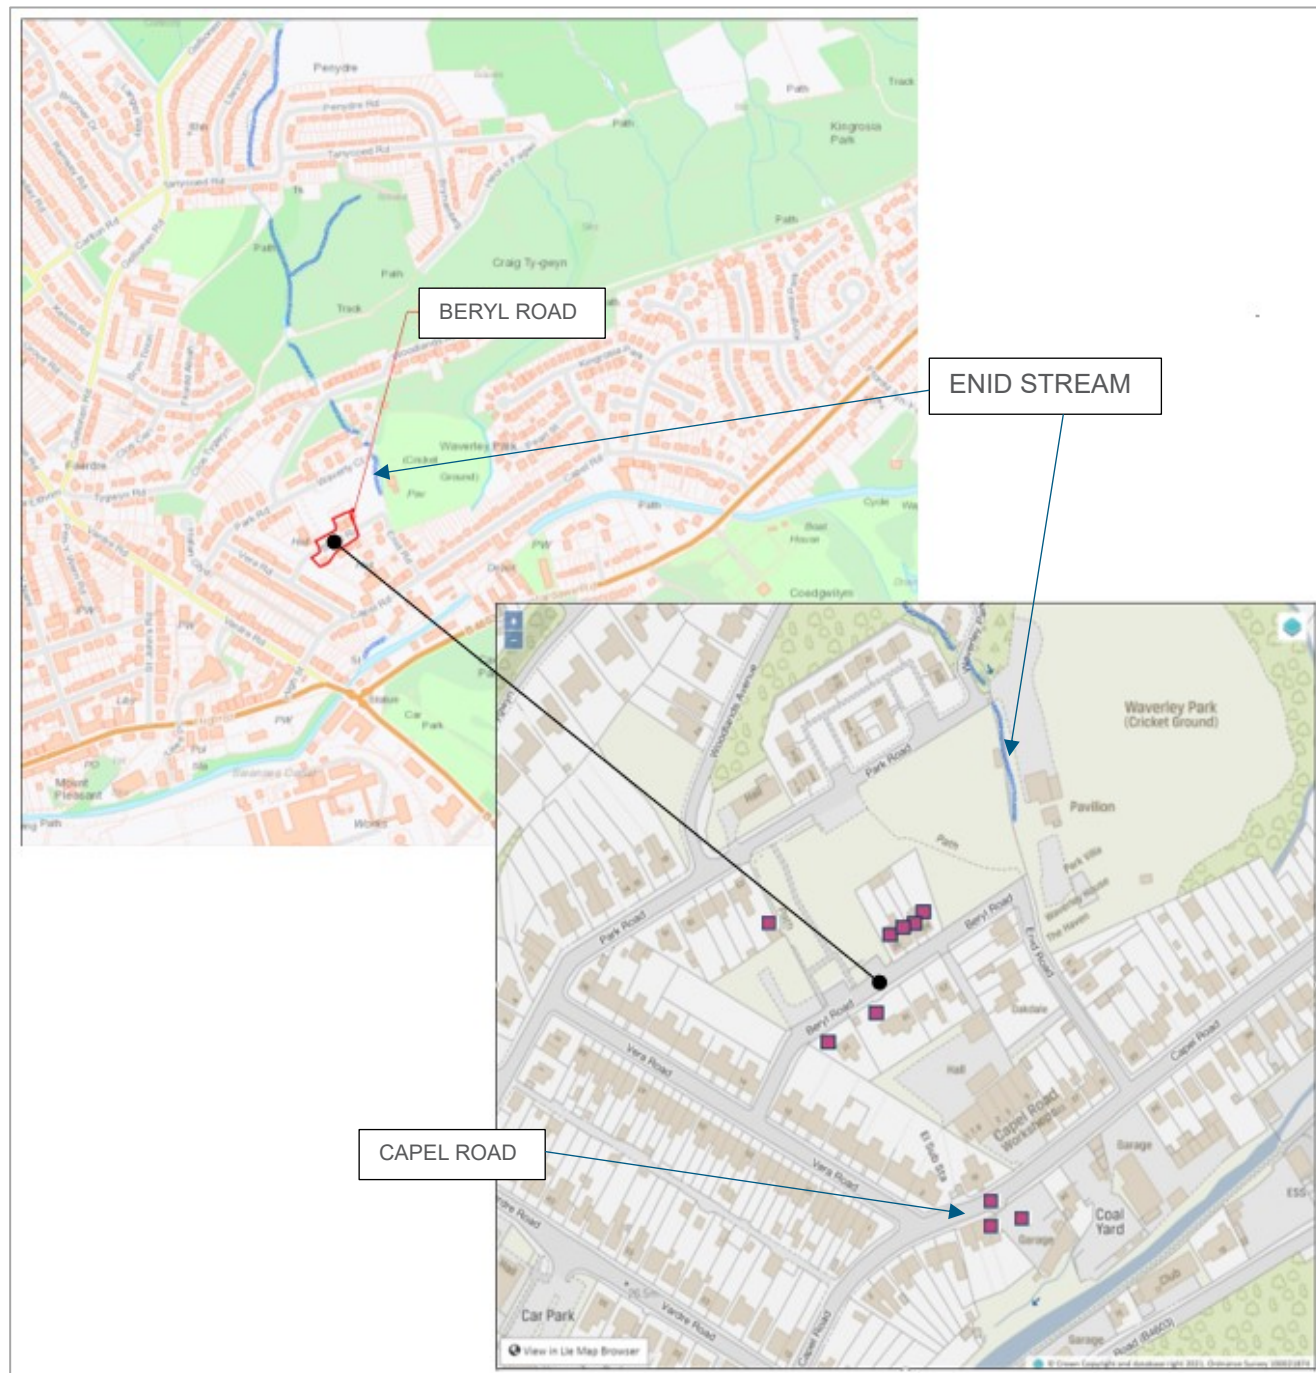
**Figure 2-1 - Location of reported flood incidents - Beryl Road, 16 February 2020**

The general location of the affected area of Beryl Road in relation to Clydach is indicated by the red line boundary in **Figure 2-1**. The locations of the affected properties are shown within the figure inset.

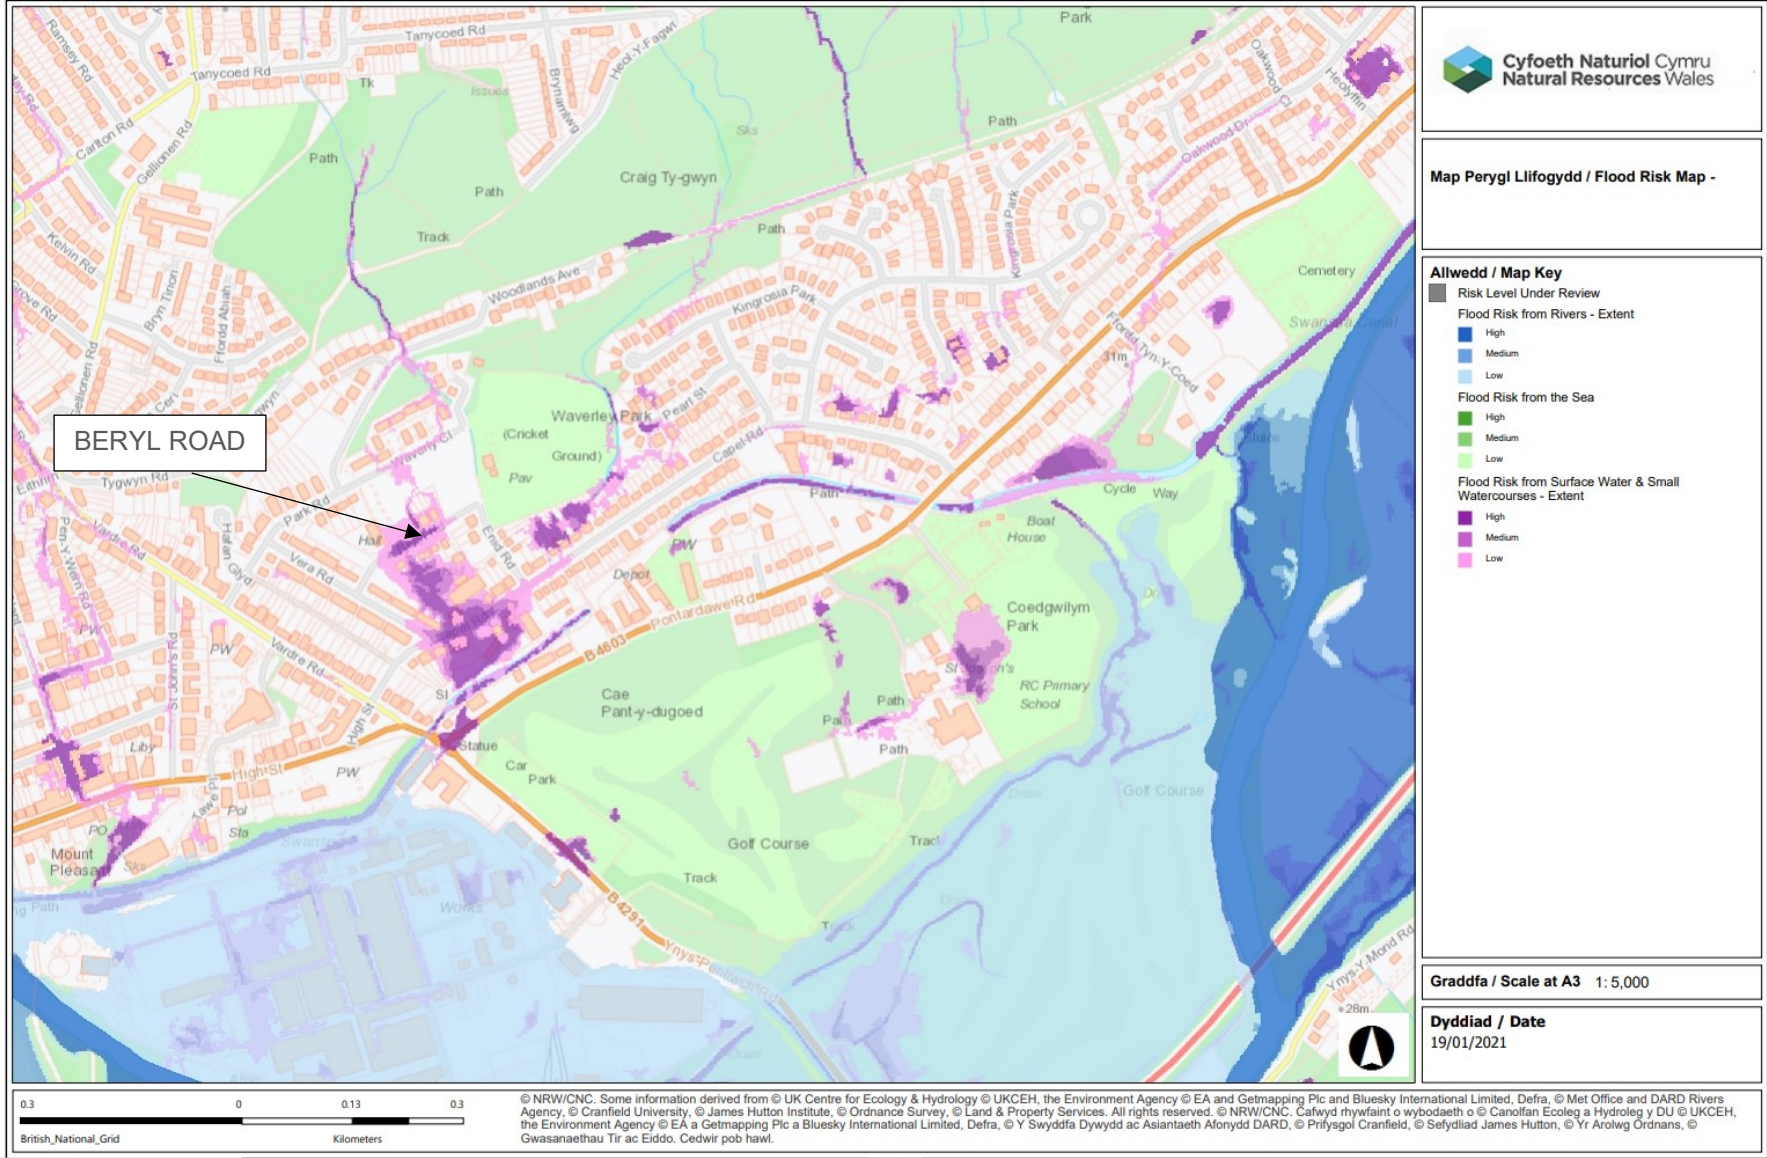
Figure 2-2 - NRW Flood Map for Surface Water and Small Watercourses.

The location of Beryl Road in relation to local areas predicted to be at risk of flooding from surface water is shown in **Figure 2-2**. The areas at flood risk are based on Natural Resources Wales' (NRW) Flood Risk Assessment Wales (FRAW) map.

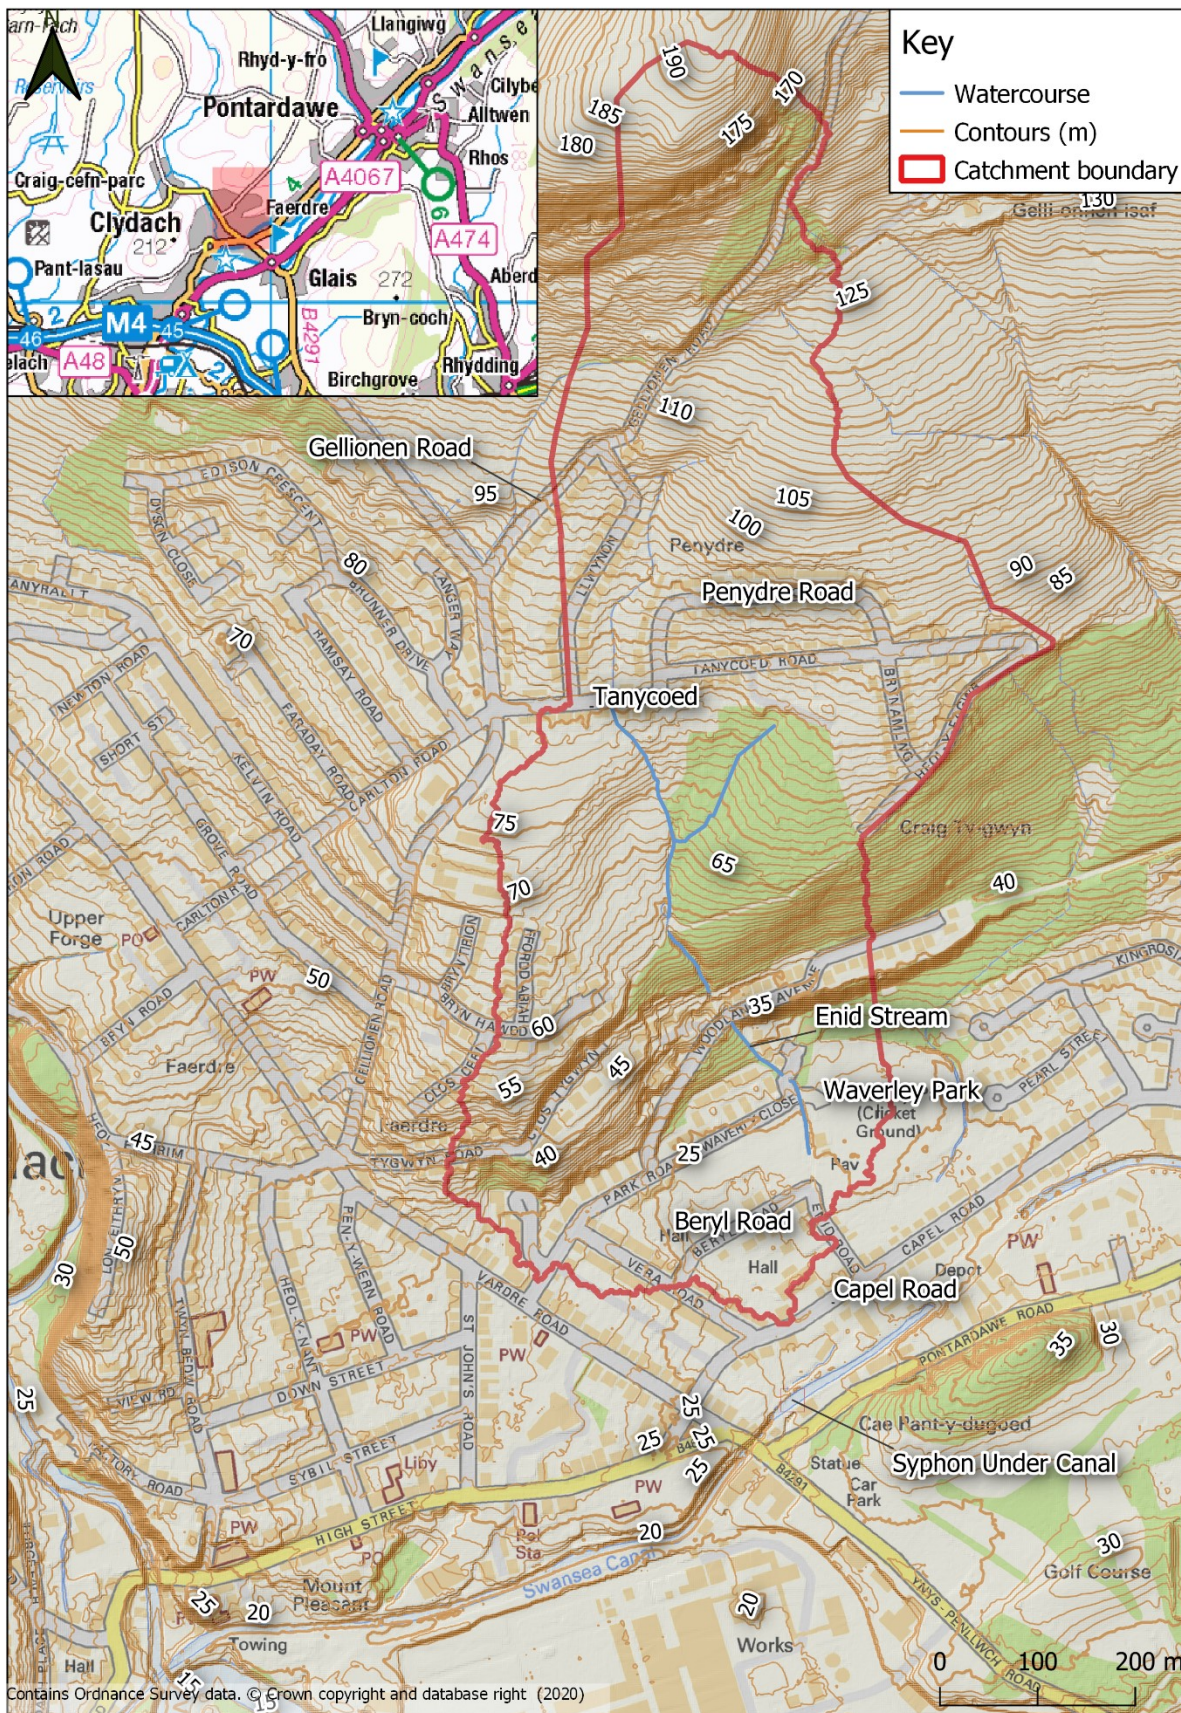
**Figure 2-3 – Landform and catchment boundary in area of Beryl Road; the numbers are the contour intervals given in metres above mean sea level.**

The contributing surface water catchment to Beryl Road (i.e. the watershed) is shown in **Figure 2-3**; covers an area of 0.43km<sup>2</sup>. In this figure the flows are directed from north to south down the contours. The contributing catchment extends for approximately 1km above Beryl Road to the highest part of the catchment above Gellionen Road.

Reference has been made to contoured LiDAR<sup>1</sup> data to derive the general falls in level in the different sections of the overall land drainage catchment in which Beryl Road lies (i.e. the red outline area on Figure 2-3).

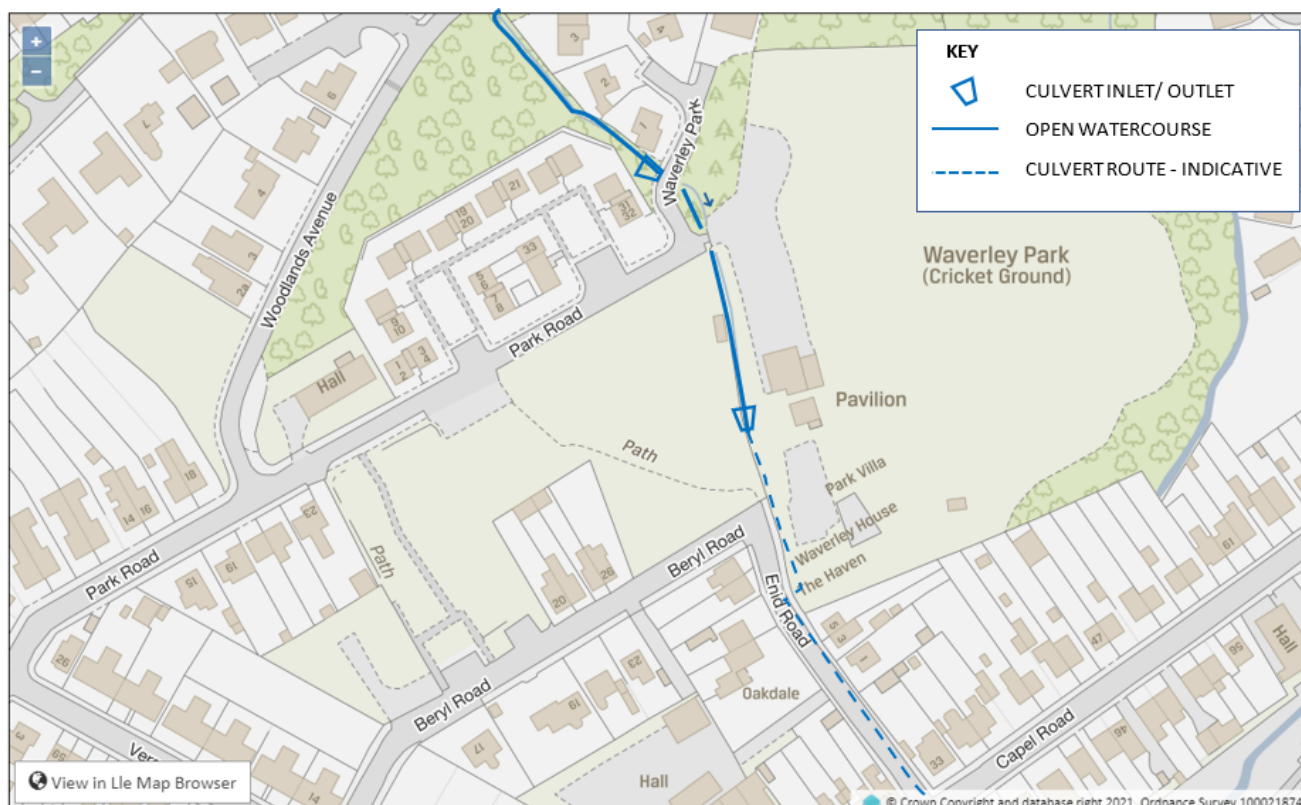
As indicated on Figure 3-3 the stream course continues in open channel southwards along the western side of the cricket ground to a screened culvert inlet near the pavilion.

**Figure 3-3 – Key culvert and open channel sections of Enid Stream north and east of Beryl Road.**

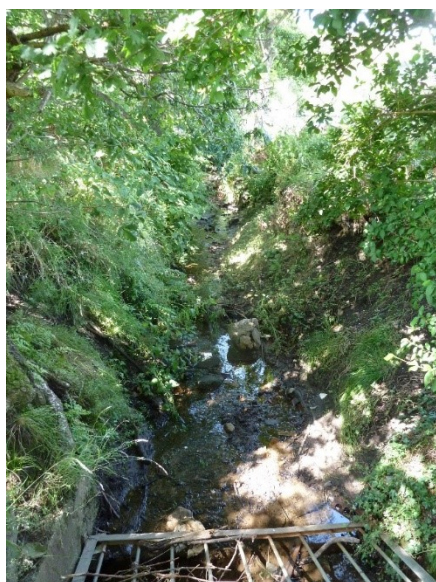
**Figure 3-4 – View of the Enid Stream upstream of the culvert screen.**

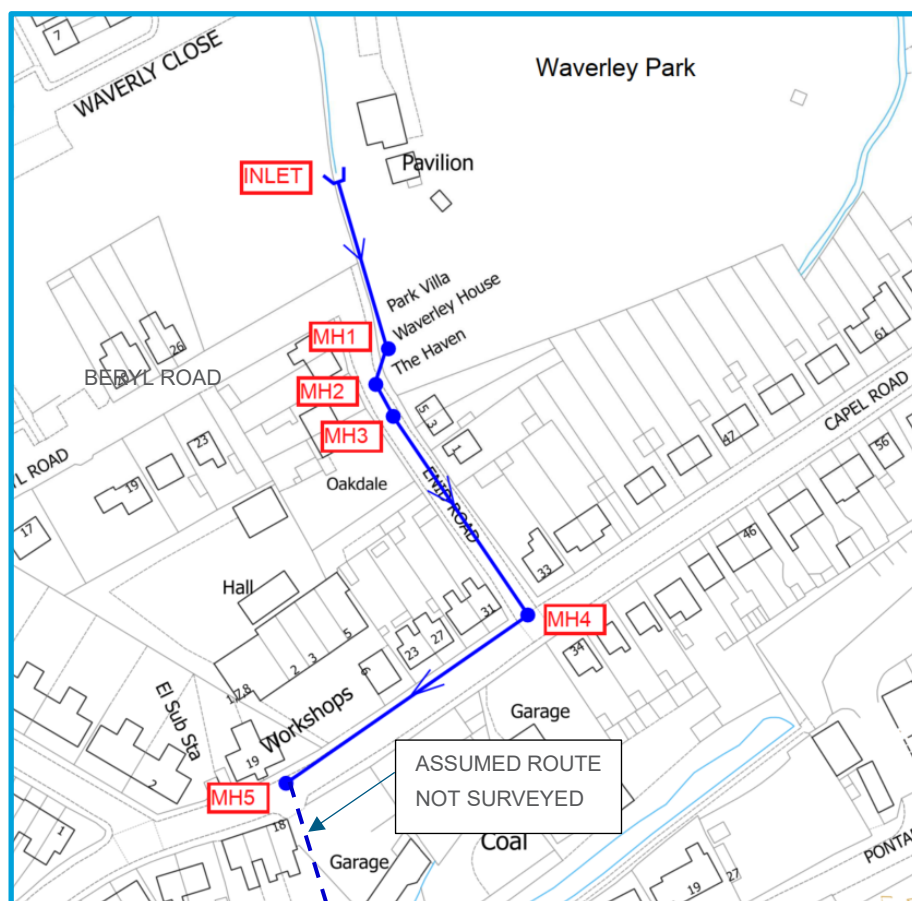
**Figure 3-6 – The culverted section of the Enid Stream in Enid Road and Capel Road.**

CCTV survey information indicates that the culvert begins as a 450mm diameter concrete pipe. The pipe transitions to a 600mm diameter pipe at chamber MH1 (Figure 3-6). A dog leg in the route of the culvert to the centre of Enid Road (MH2) marks a new section which was replaced sometime between 2016 and 2020, due to the deteriorated condition of the previous arrangement. From the centre of Enid Road, the culvert continues as 600mm dia. pipe to the junction with Capel Road. Here it turns through a right angle and follows the highway in a south-west direction to MH5.

It is noted that from the records available at the time of writing, there is no evidence of this section within Capel Road having been surveyed completely. The survey records cite various reasons such as the line being surcharged or encountering debris blocking the pipe leading to termination of the surveys. Therefore, the exact route and condition of the culvert along the lower portion of Capel Road and south towards the canal is uncertain. There is good confidence in the chamber locations within Capel Road as all manhole covers are visible in the highway.

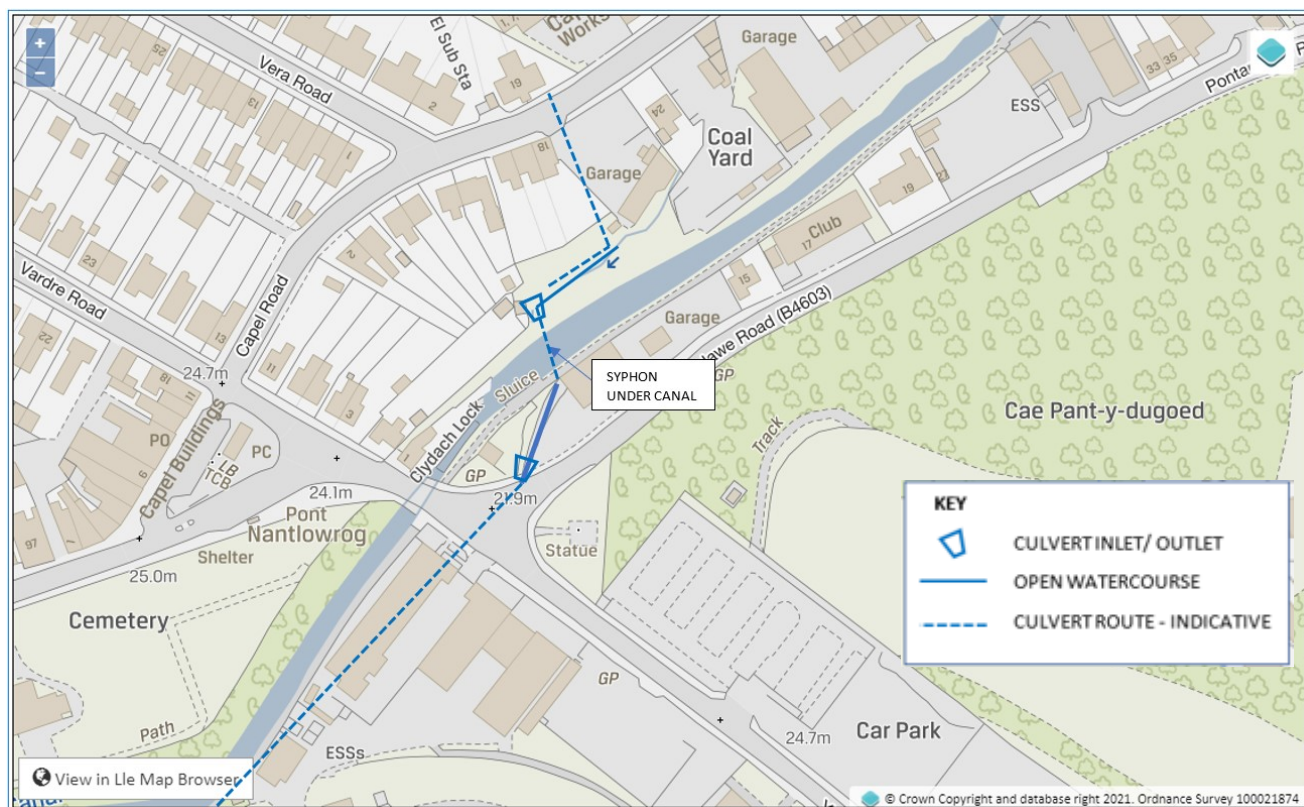
**Figure 3-7 – Route of Enid Stream south of Capel Road via a syphon to the Canal outfall.**

Internal photographs of chamber MH5 on Capel Road confirm that there is a 90-degree bend through the chamber. This suggests that the culvert is routed south from Capel Road between the GMD Body Repairs garage and No. 18 Capel Road, and flows towards an outfall (unlocated) to the open channel ditch.

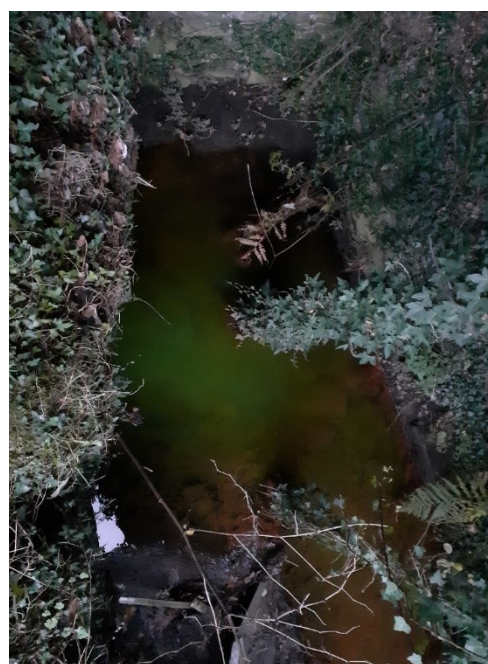
**Figure 3-11 – Outlet from syphon south of the canal (dye trace visible).**

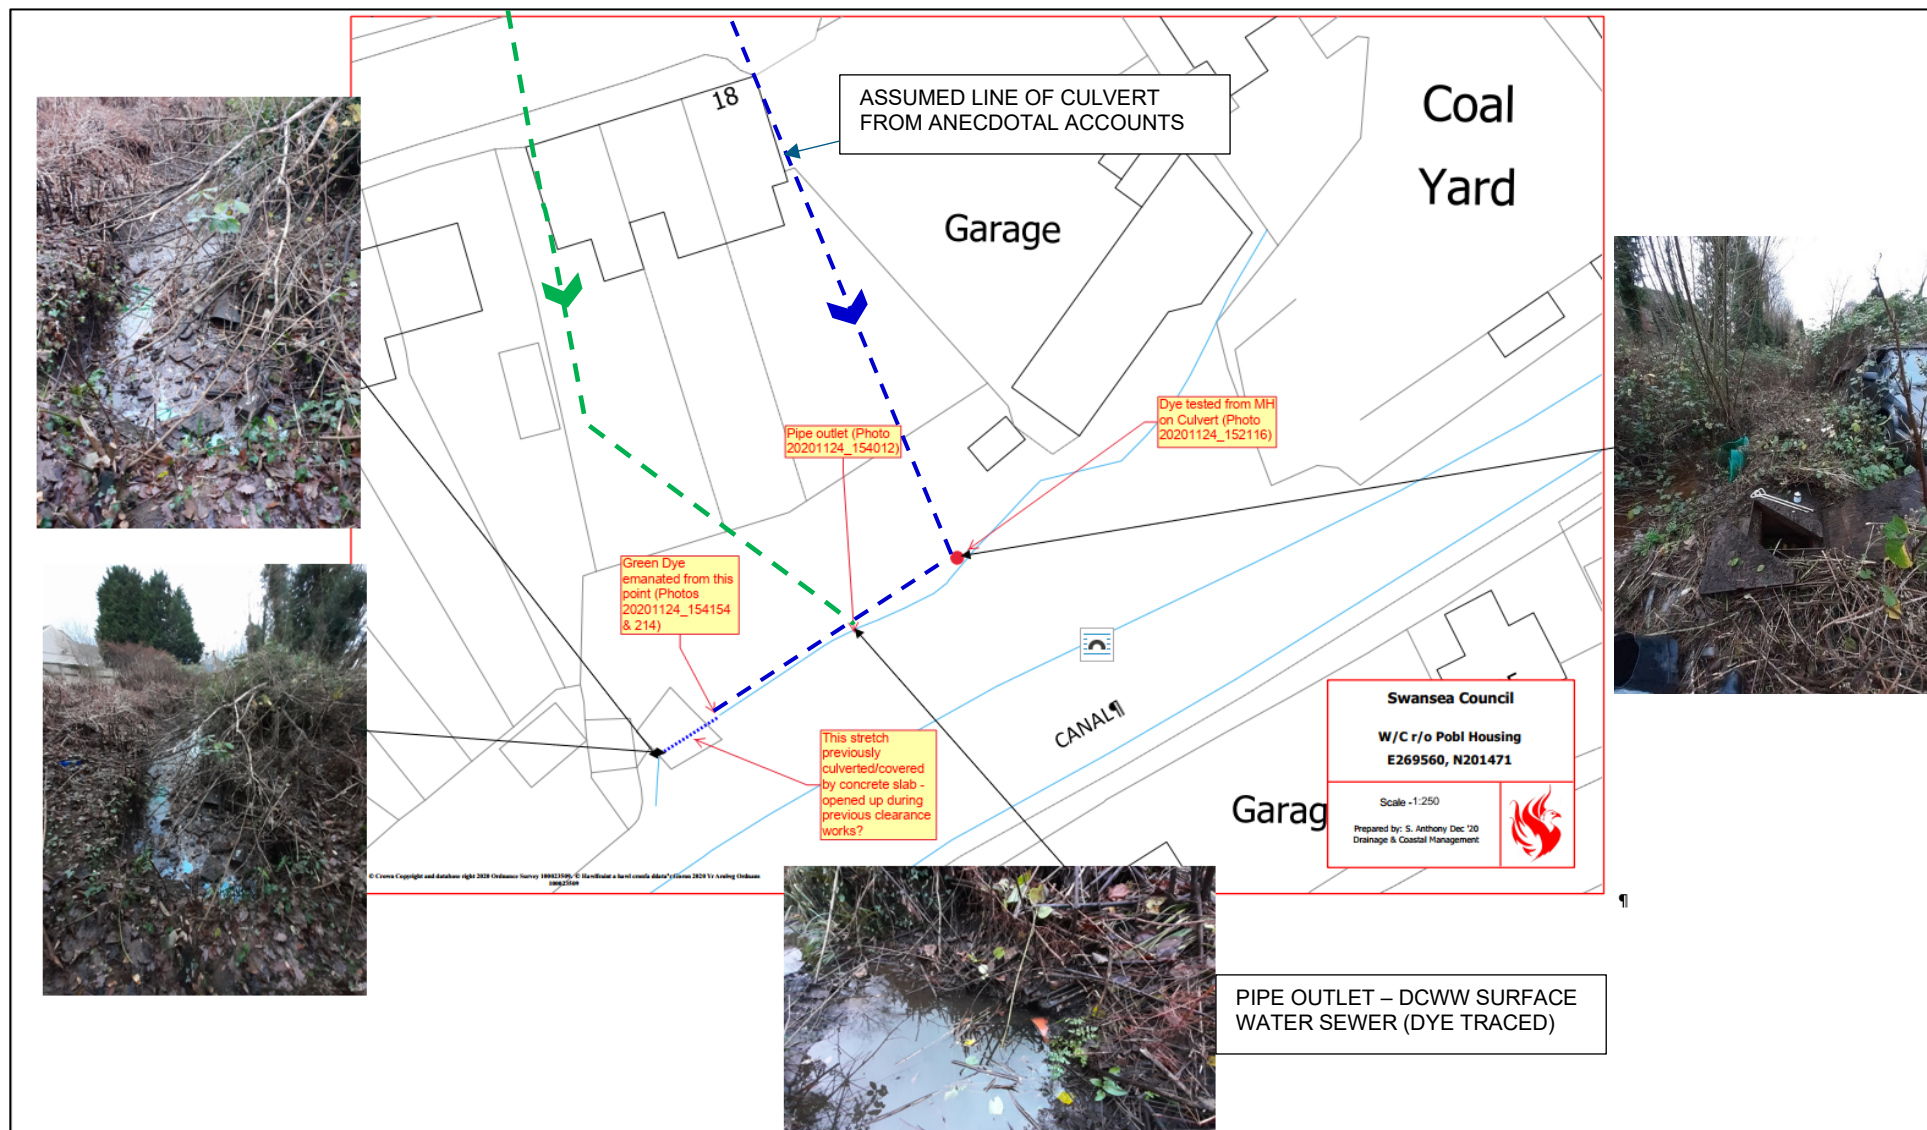
The course of the ditch runs south-west, parallel to Swansea Canal, before turning through approximately 90 degrees to cross under the canal in an inverted syphon.<sup>3</sup> The headwall to this syphon is shown in Figure 3-10. The poor condition of the ditch channel and the significant debris at the inlet to the inverted syphon are shown in figures Figure 3-9, Figure 3-10 and Figure 3-12 below.

As part of this investigation a chamber was identified near the ditch in an area of overgrown scrub south of No. 18 Capel Road (see Figure 3-8 and Figure 3-12). The route from this chamber to the stream was determined through dye tracing. Although the outlet position could not be located, the dye was observed to emanate into the stream at the location indicated on Figure 3-12 and is taken as evidence of a positive connection to the ditch.

Figure 3-12 – General layout of sections of “Enid” Stream south of Capel Road to the Canal Syphon.

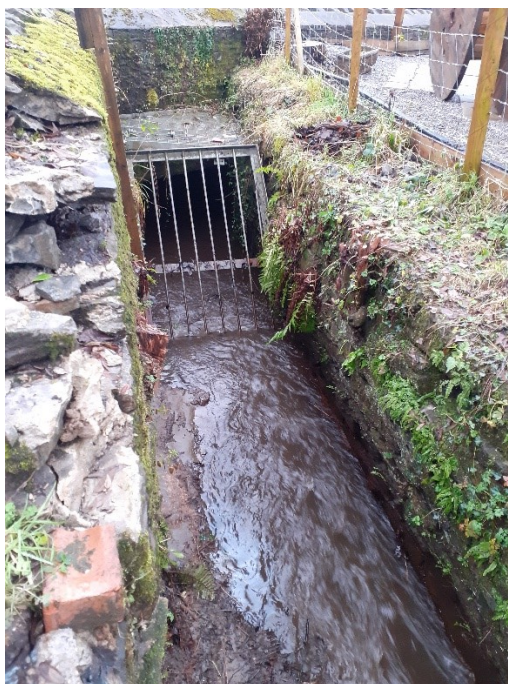
**Figure 3-13 – B4603 Pontardawe Road (Men’s Shed) Screen – Culvert entrance to canal through Mond Works.**

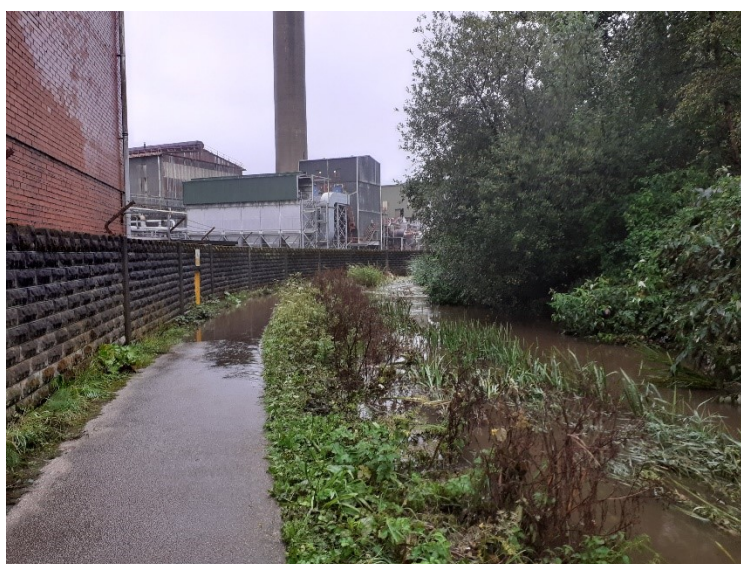
**Figure 3-14 – Canal tow path at Mond Works – outlet from culvert approximately on bend.**

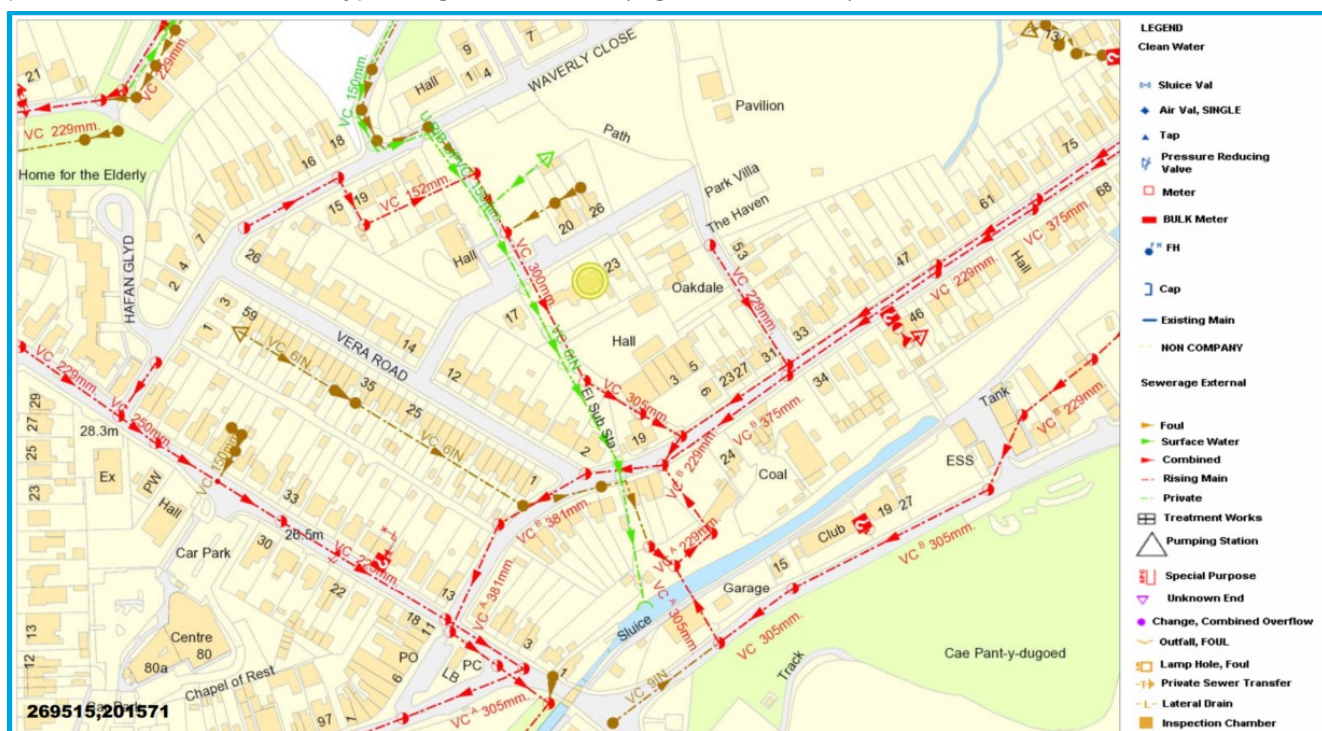
**Figure 4-1 – Extract of DCWW’s Sewerage Plan.**

However, a separate DCWW surface water sewer runs approximately north-to-south from Woodlands Avenue to outfall to the ditch feeding the inverted syphon under the Swansea Canal. DCWW's records show this to be a 150mm diameter surface water sewer indicated by the green line on Figure 4-1.<sup>4</sup> It crosses Beryl Road, picking up the road drainage, and continues south through the garden of No. 19. Although the record drawing indicates an outfall to the canal, dye testing has confirmed that it actually discharges to the ditch that runs parallel to the canal before syphoning underneath it (Figure 3-12 above).

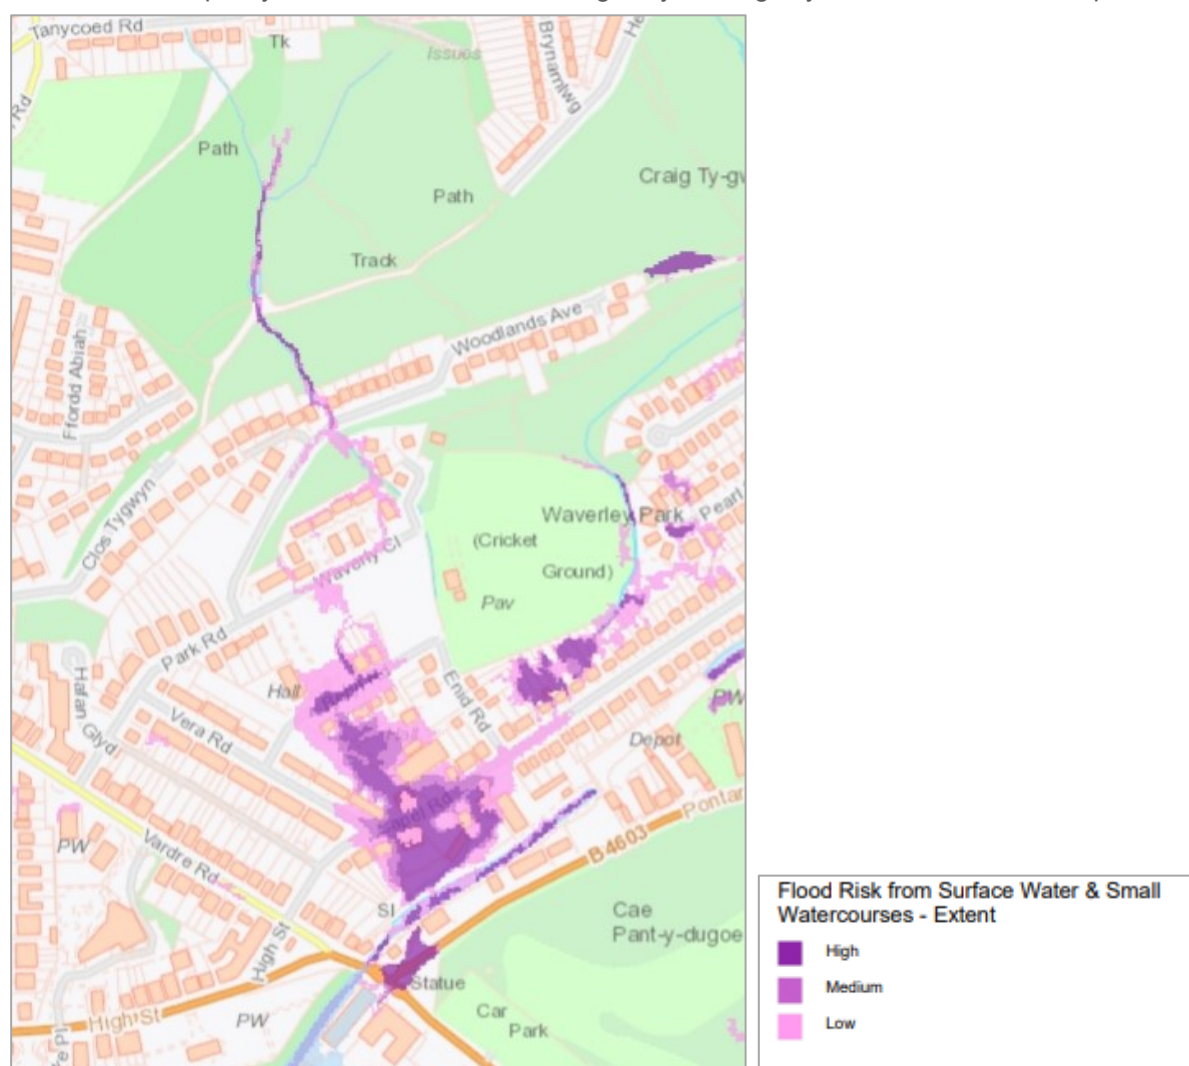
**Figure 5-1 – Extract from NRW's FRAW map – Surface Water and Small Watercourses.**

The FRAW map (Figure 5-1) shows the flood risk to Beryl Road as 'high' which, based on the NRW definitions, means that each year the chance of flooding is estimated to be greater than 1 in 30 (3.3% Annual Exceedance Probability or AEP). It is noted that this map does not directly reflect the capacity of the piped drainage system.

The map extract indicates that during a flood of this annual probability, water is predicted to escape from the watercourse between Woodlands Avenue and Waverly Close, developing an overland flow path along the road and then flowing overland towards Beryl Road and further to the south. It is noted that the detail of the map is in error with respect to the point at which out of channel flow will originate. This reflects the digital terrain model on which the map is based, and it does not include the small stream channel marked by the blue line along the western boundary of Waverley Park. However, the map does illustrate that Beryl Road lies in the shallow valley formed by the surrounding landform, with the natural flow path for overland flows directed south towards Capel Road and the Canal, as commented in Sections 2.2 and 3 above.
